Gershman Beach Stair History – Design and construction by Webb Builders, Inc.

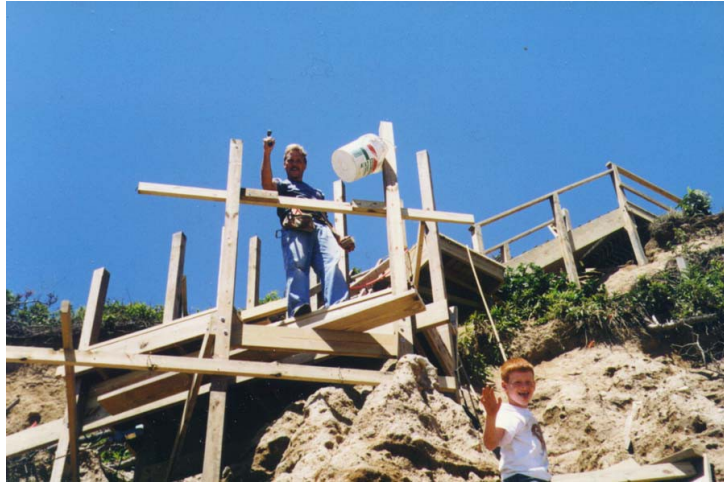
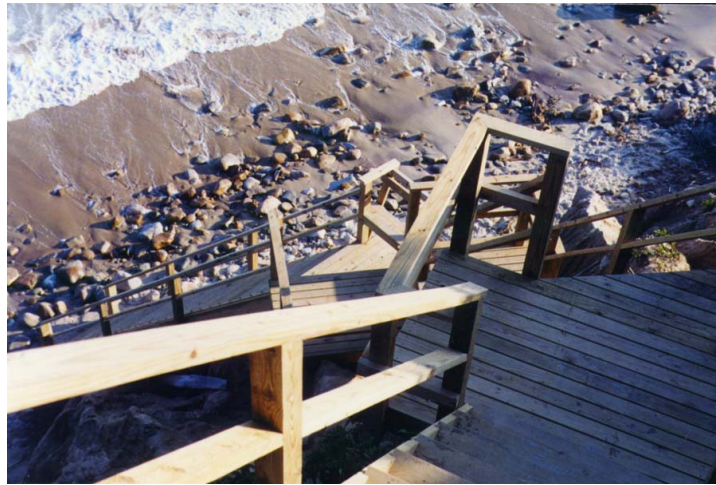
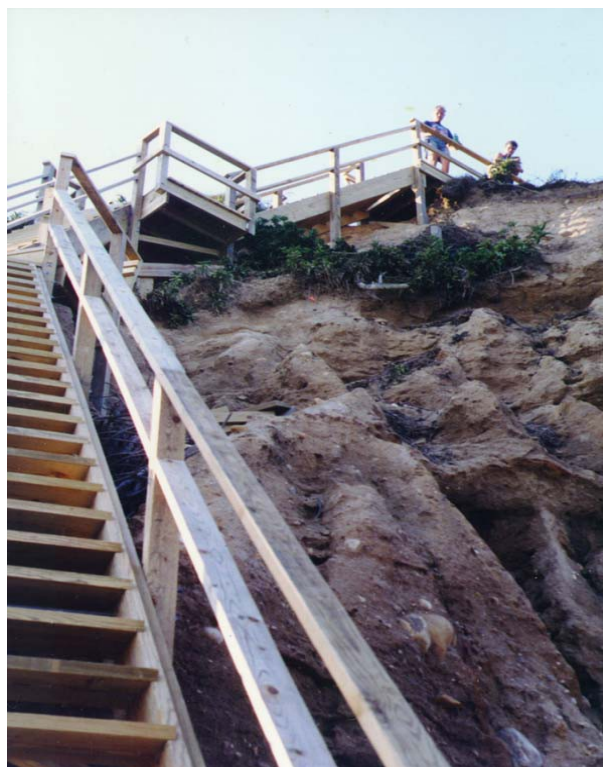
July 2001 – First set of stairs built to beach since the previous Gucki Malaly stairs washed away. This set had a multi-level landing on 4x4 posts into concrete and a long base stair to the beach.

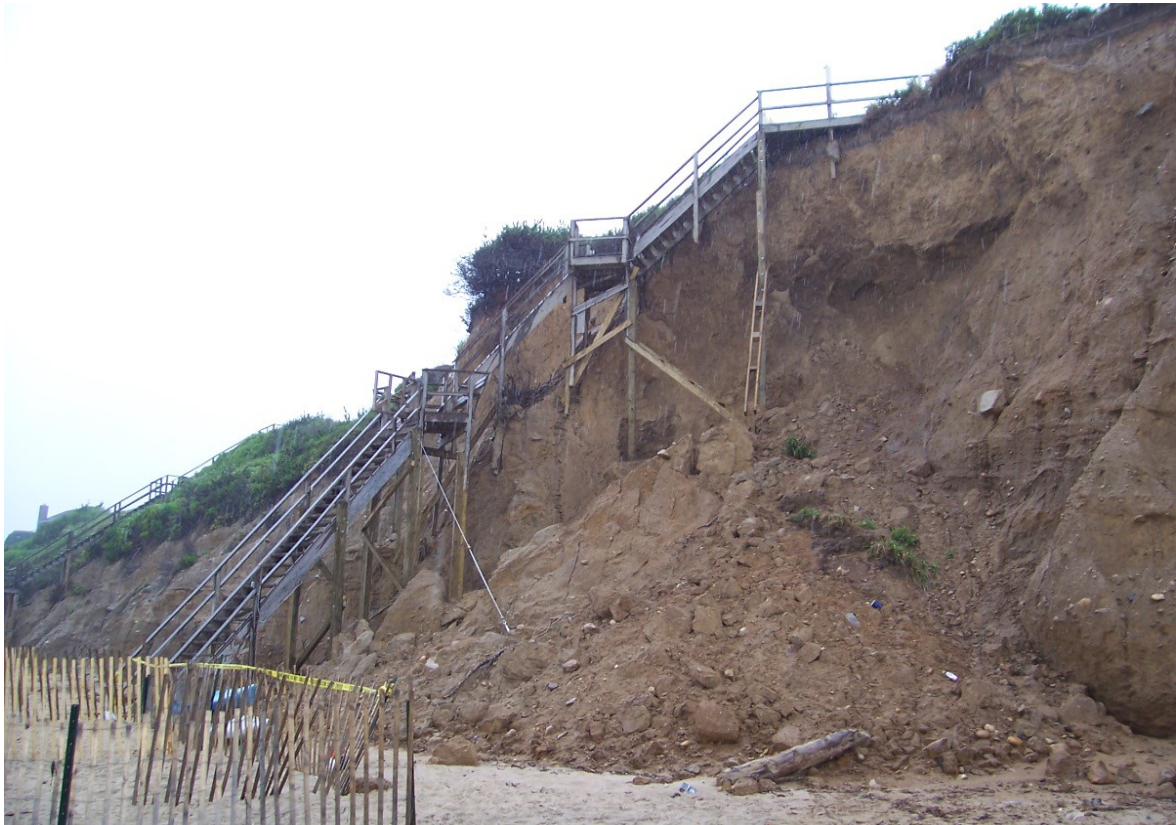
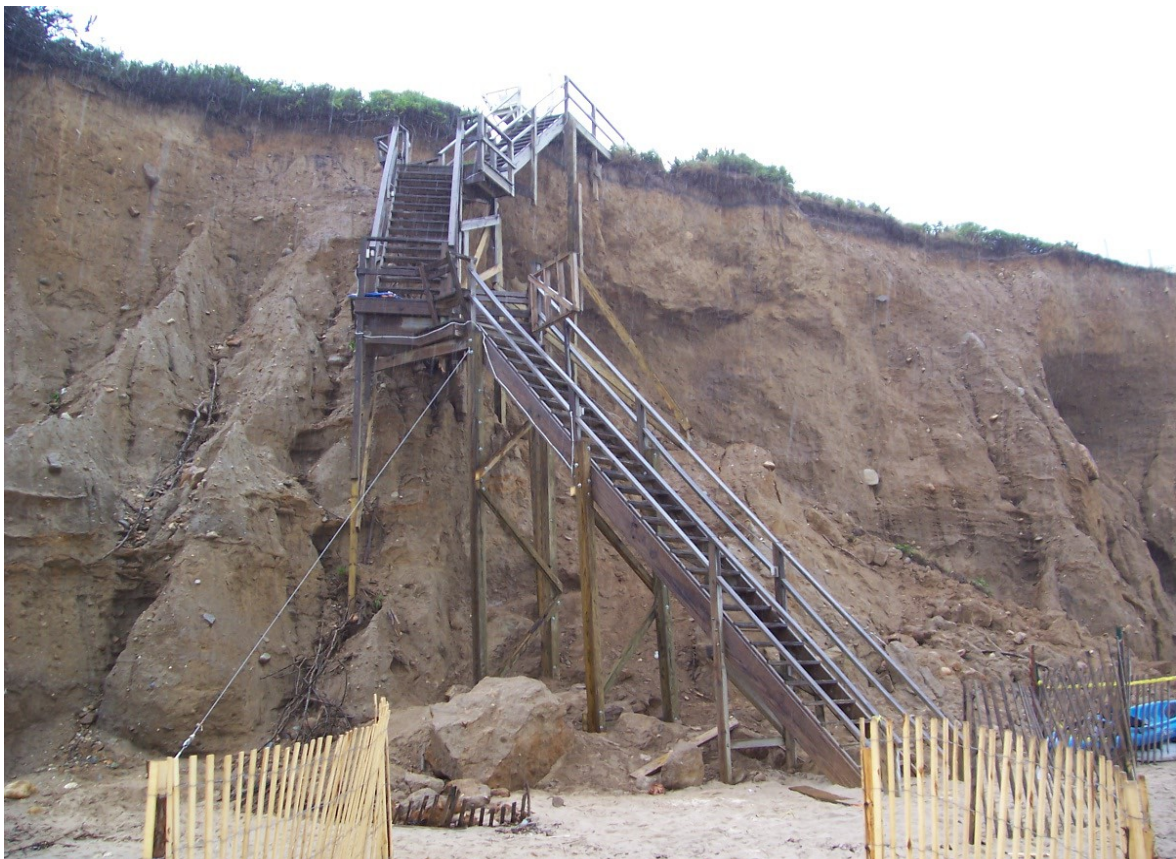
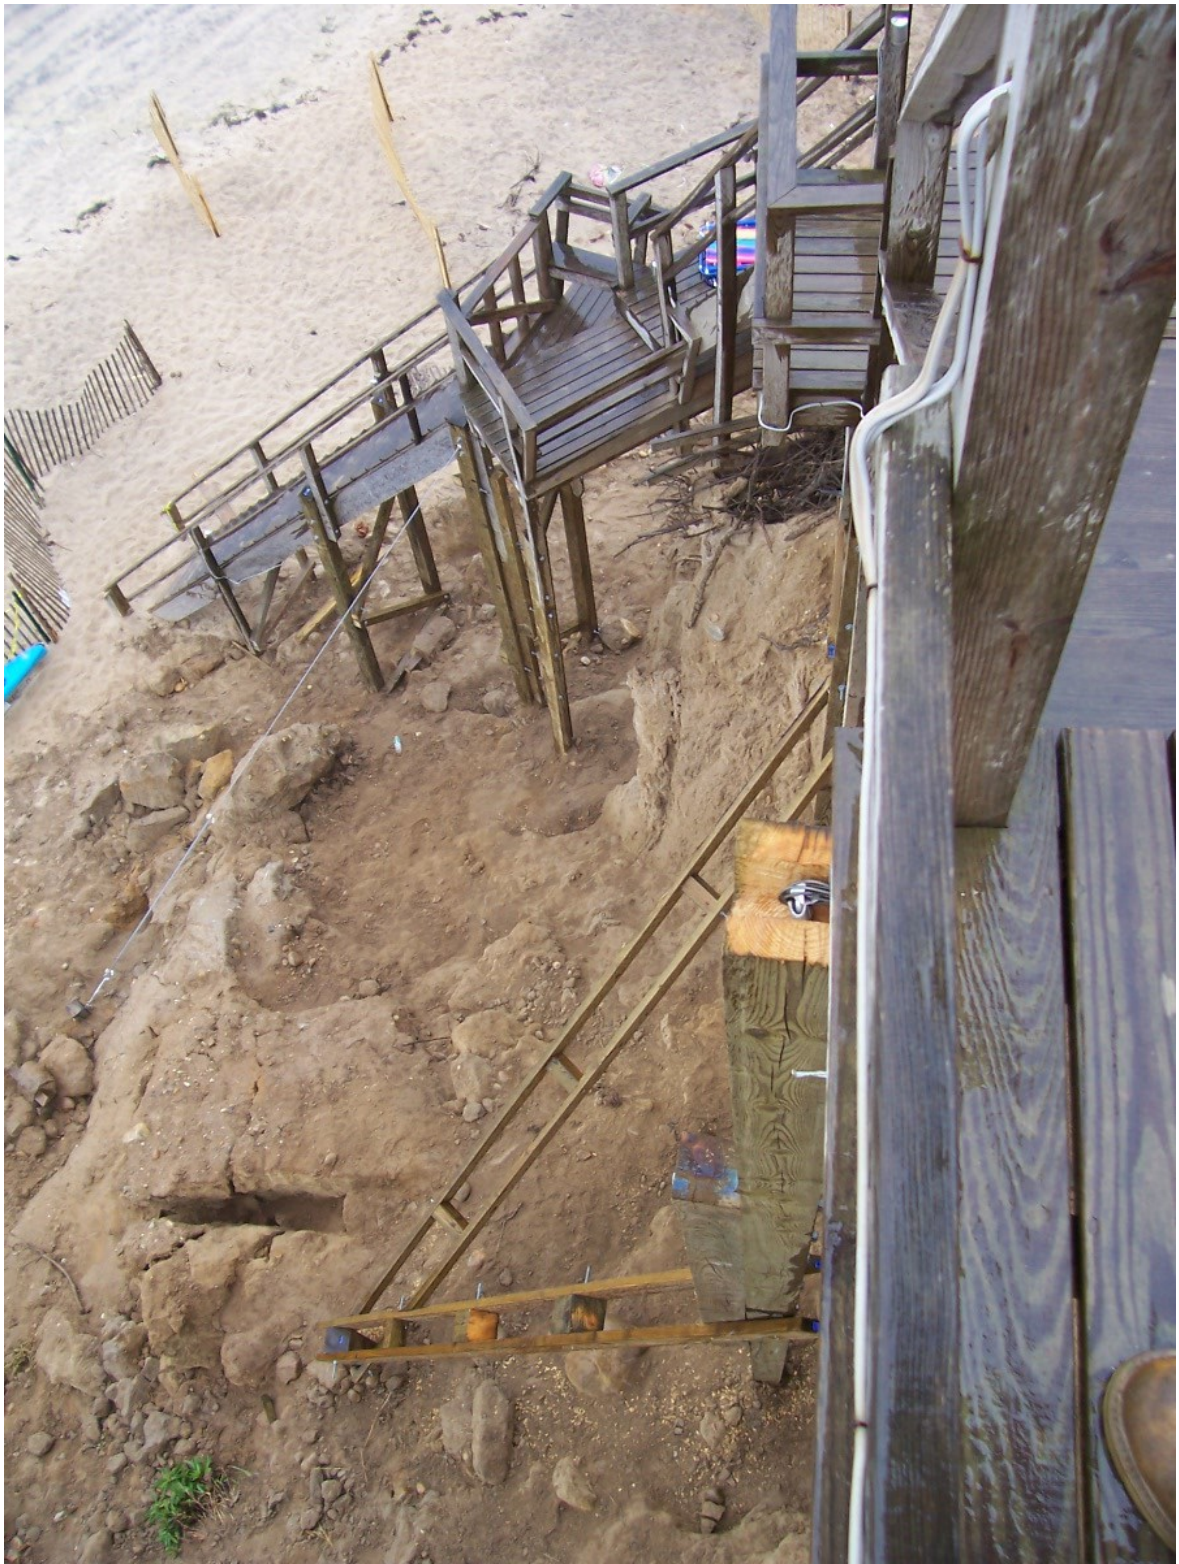
August 2006 – Repairs to stairs needed due to severe cliff erosion exposing most of the posts.

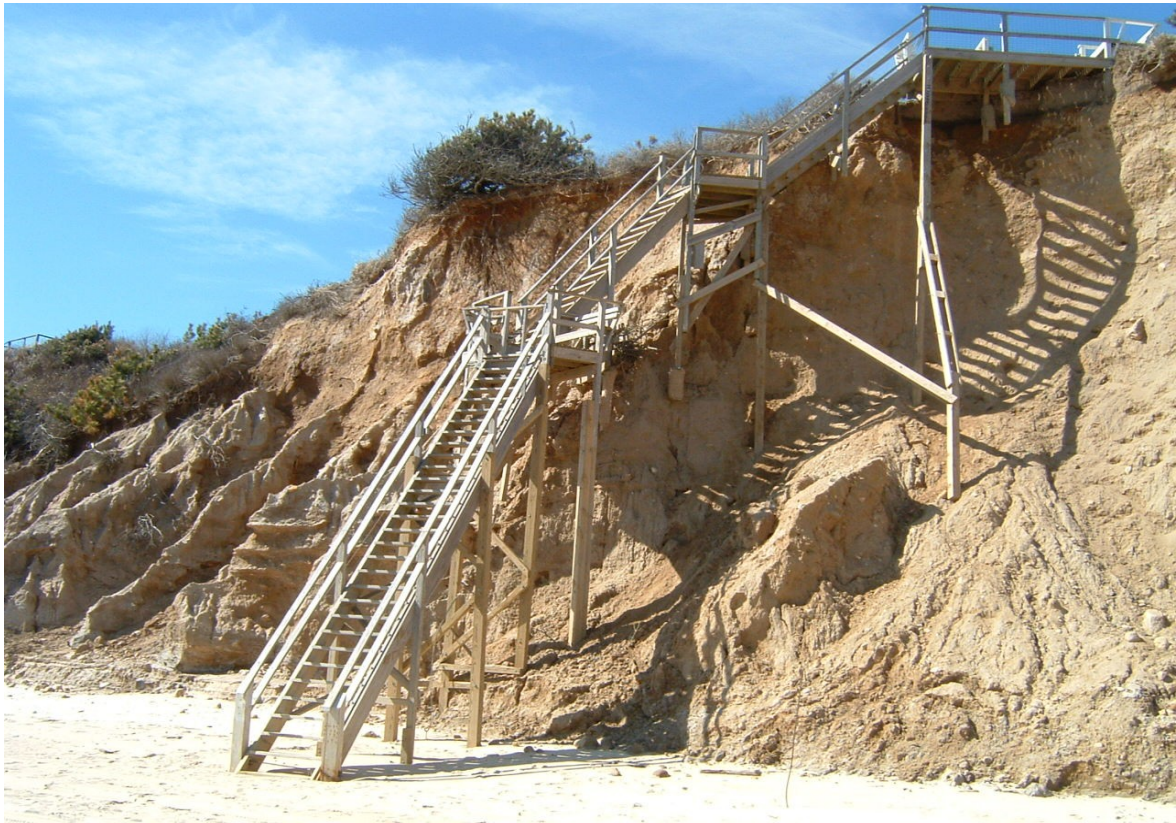
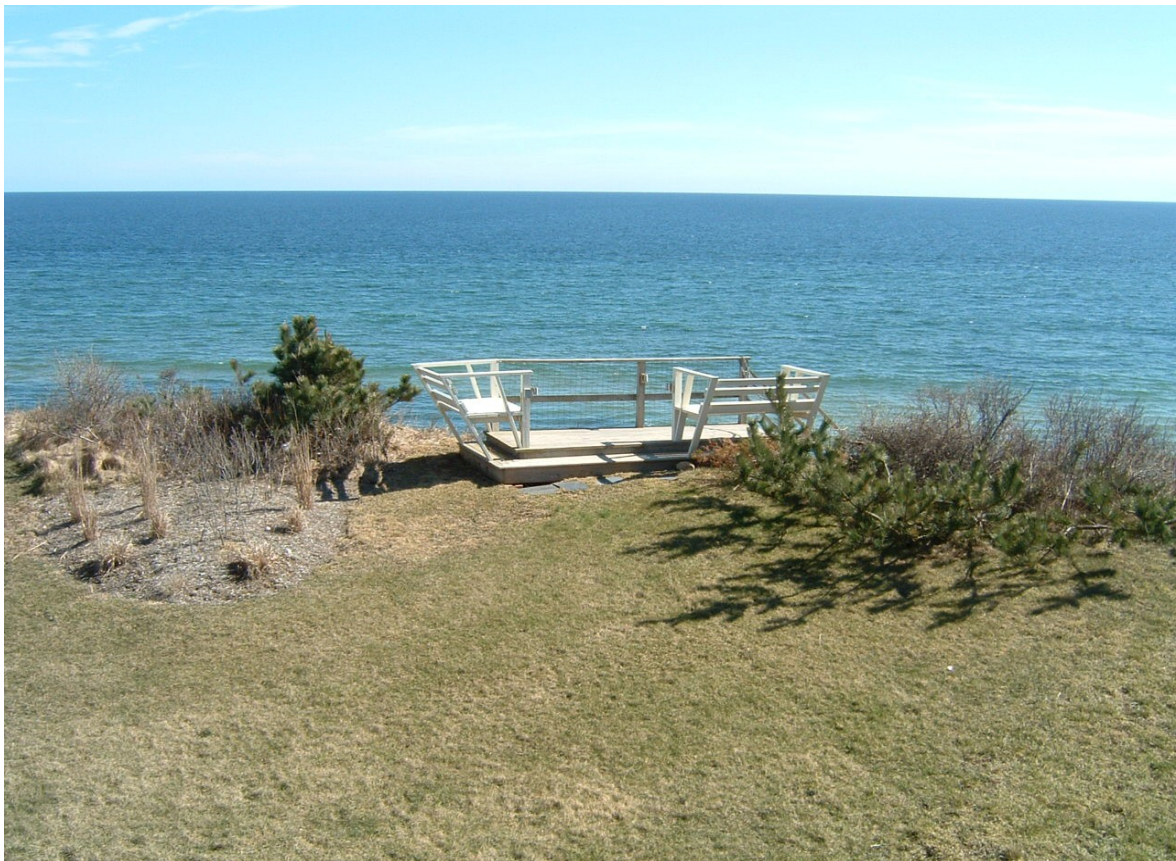
June 2007 – Continued erosion yielded an upper stair structure (top platform, upper stair set, mid-landing and mid-stair set) that was no longer supportable via posts into the cliff.

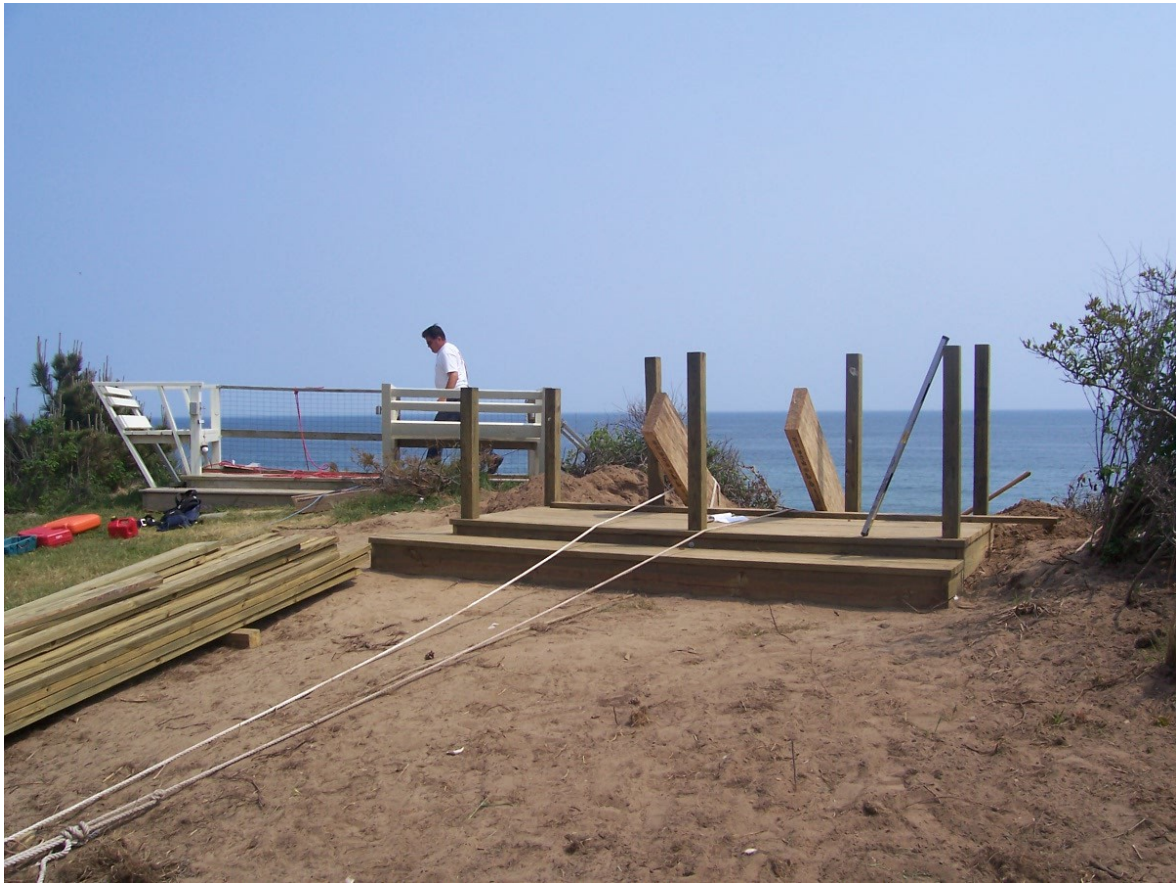
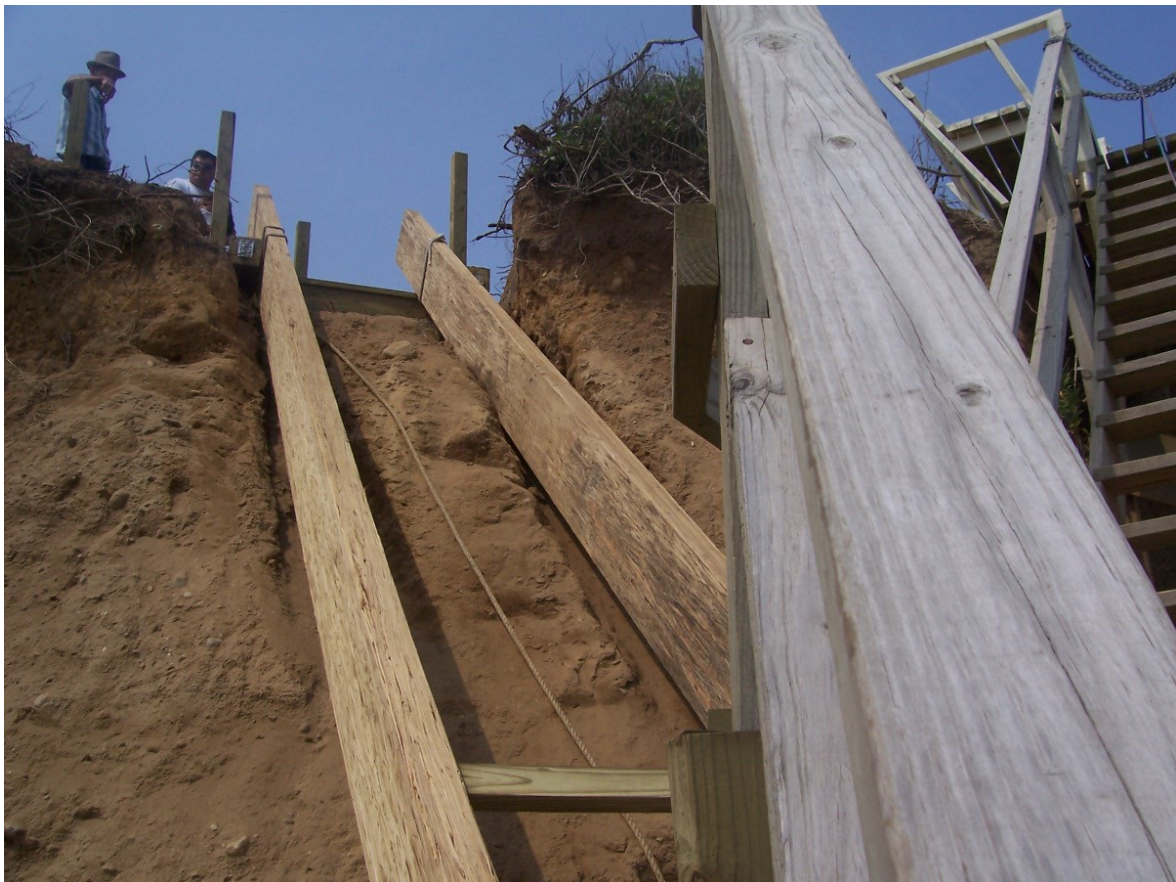
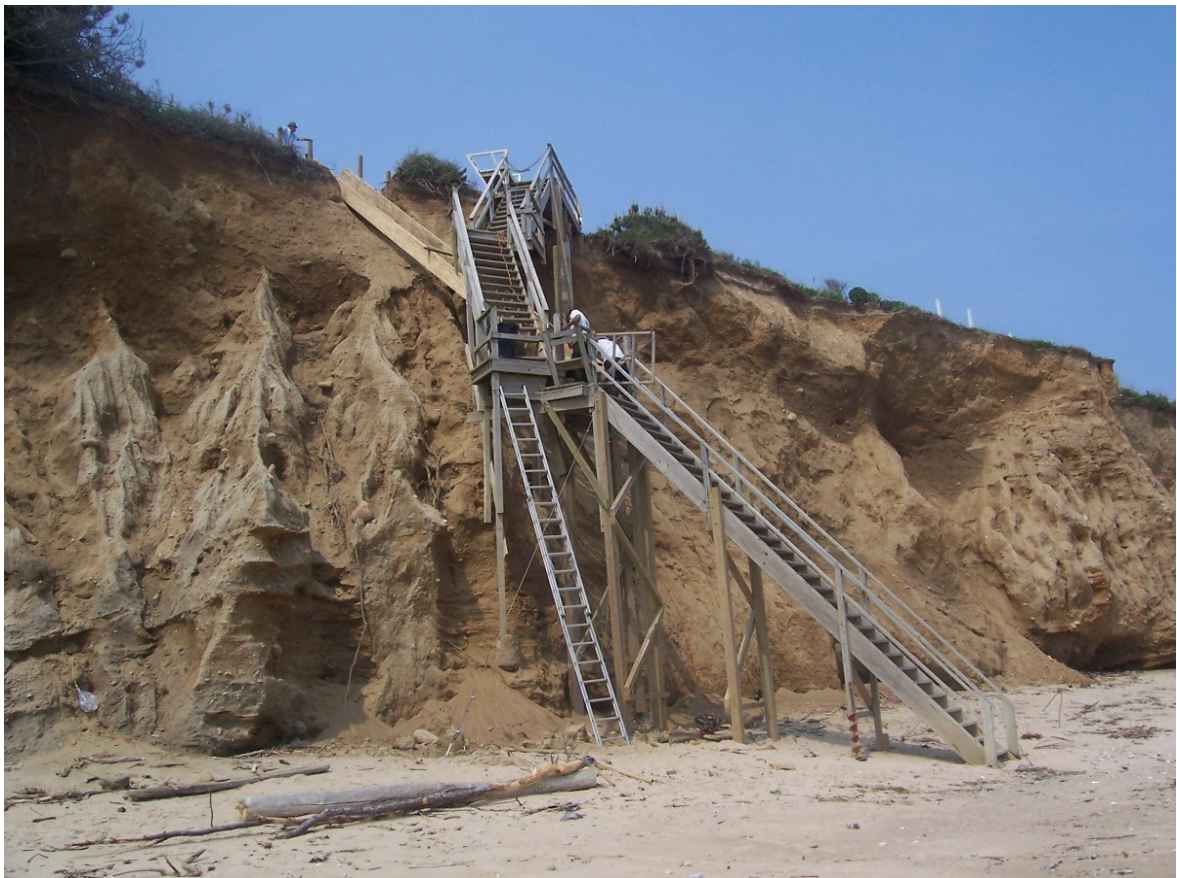
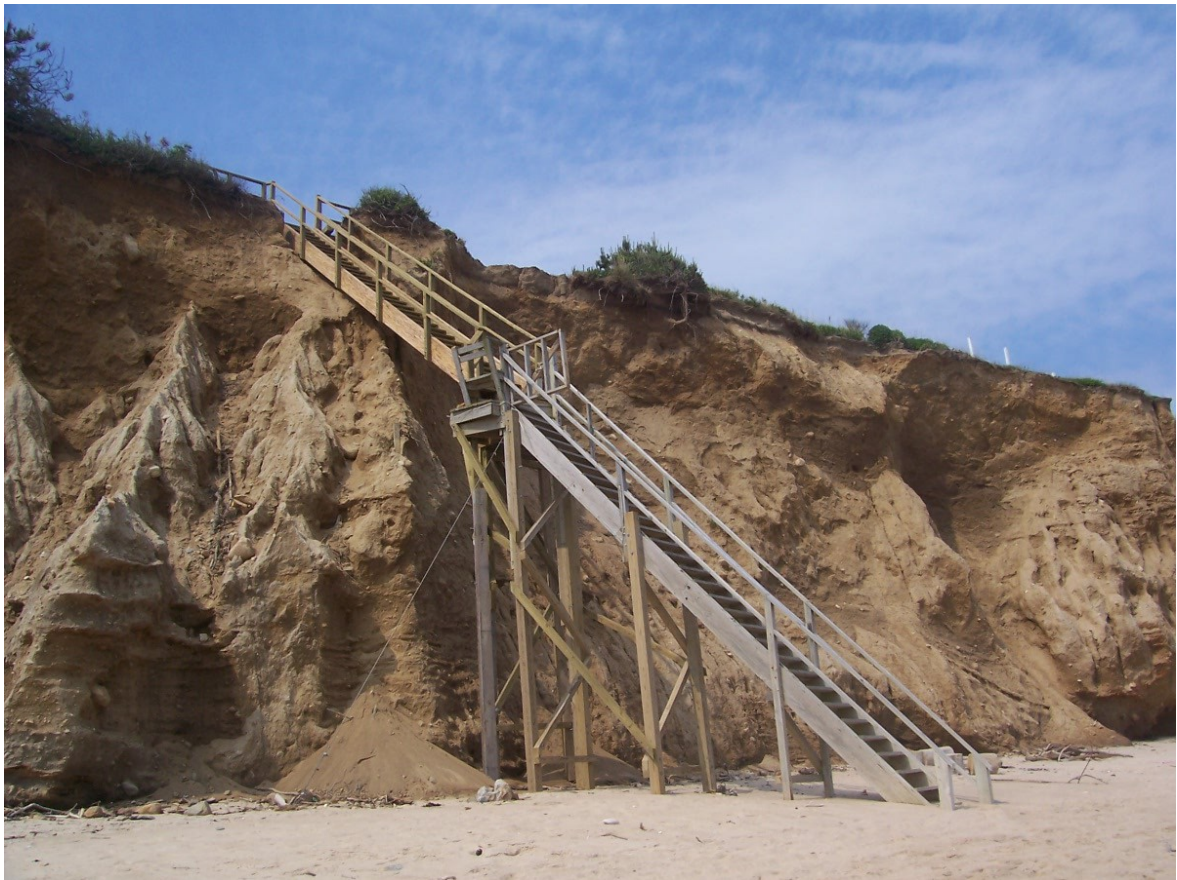
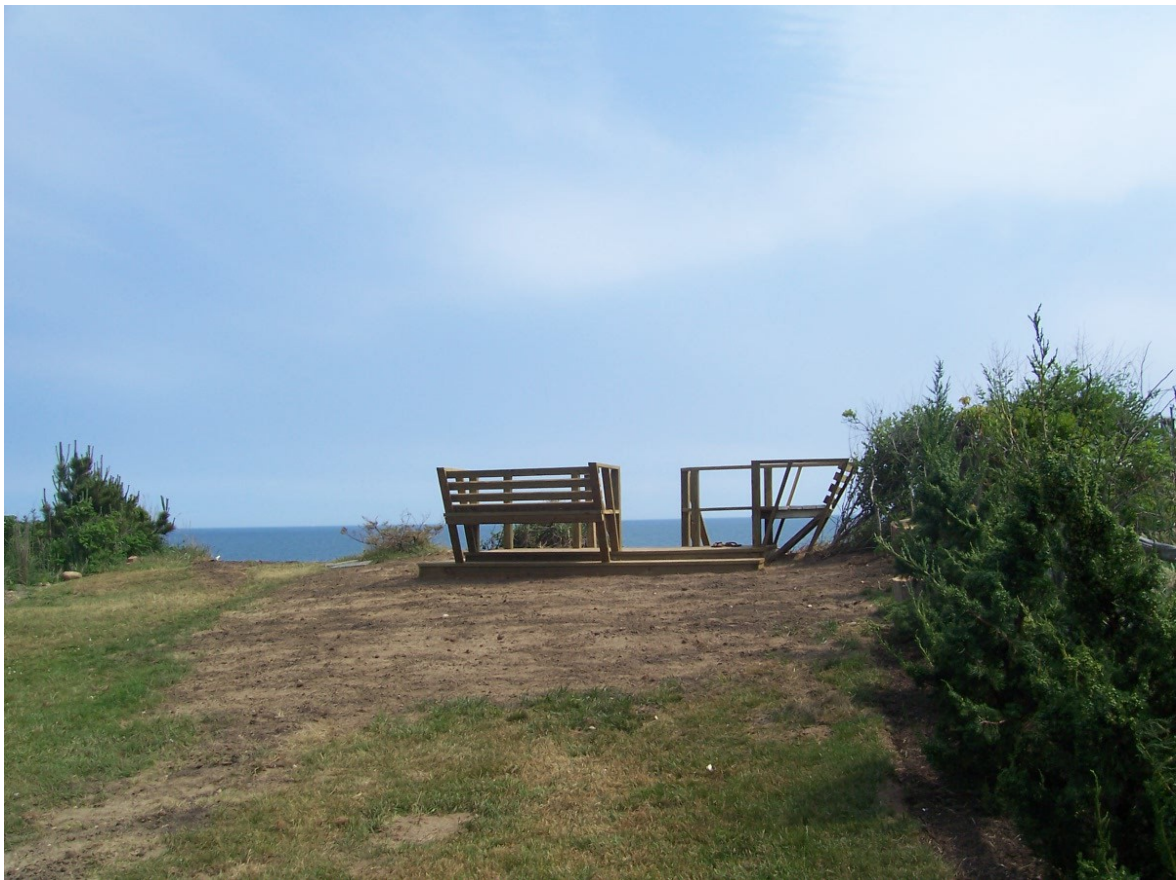
The 2007 construction photos follow. Note that the grade-beams were already buried.

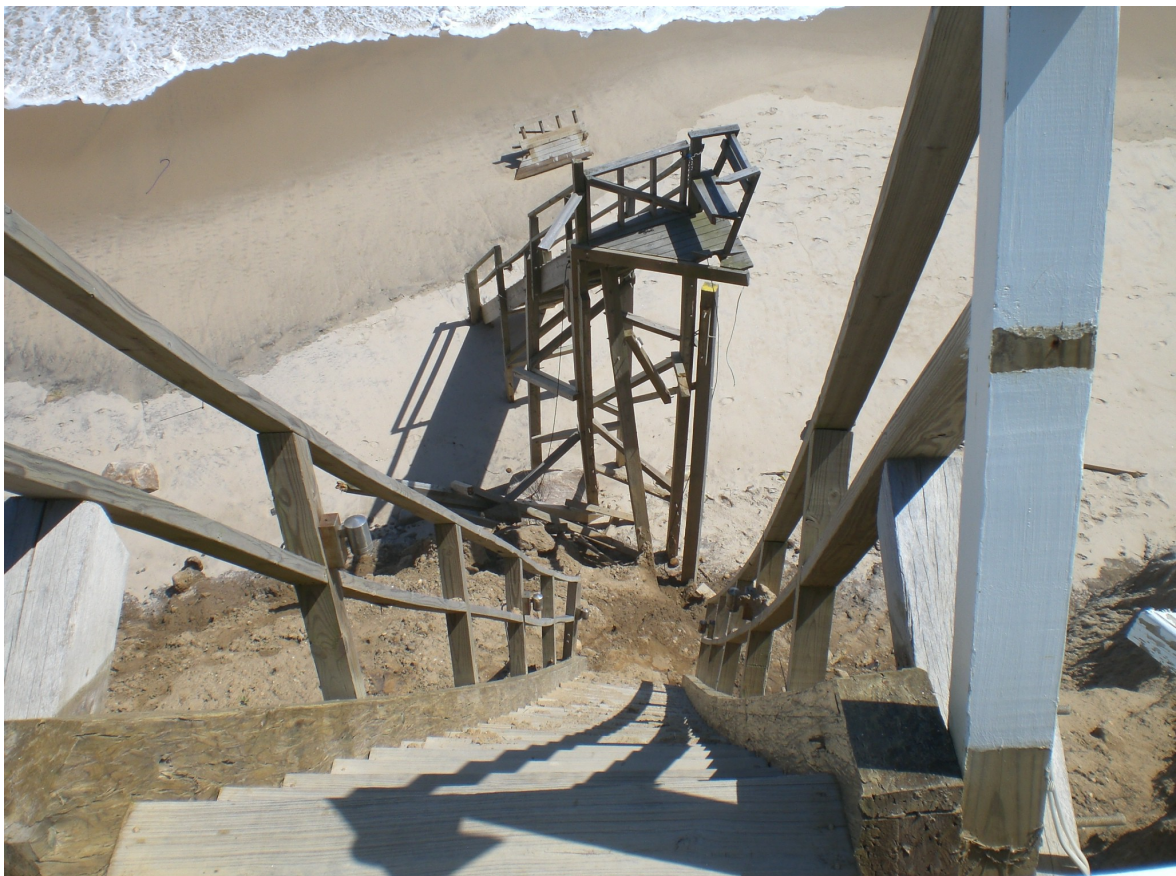
April 2010 - A monsoon rain event and resulting mud slide caused the destruction of the mid-point landing which in turn caused the upper stair to fall and rotate back to the cliff.

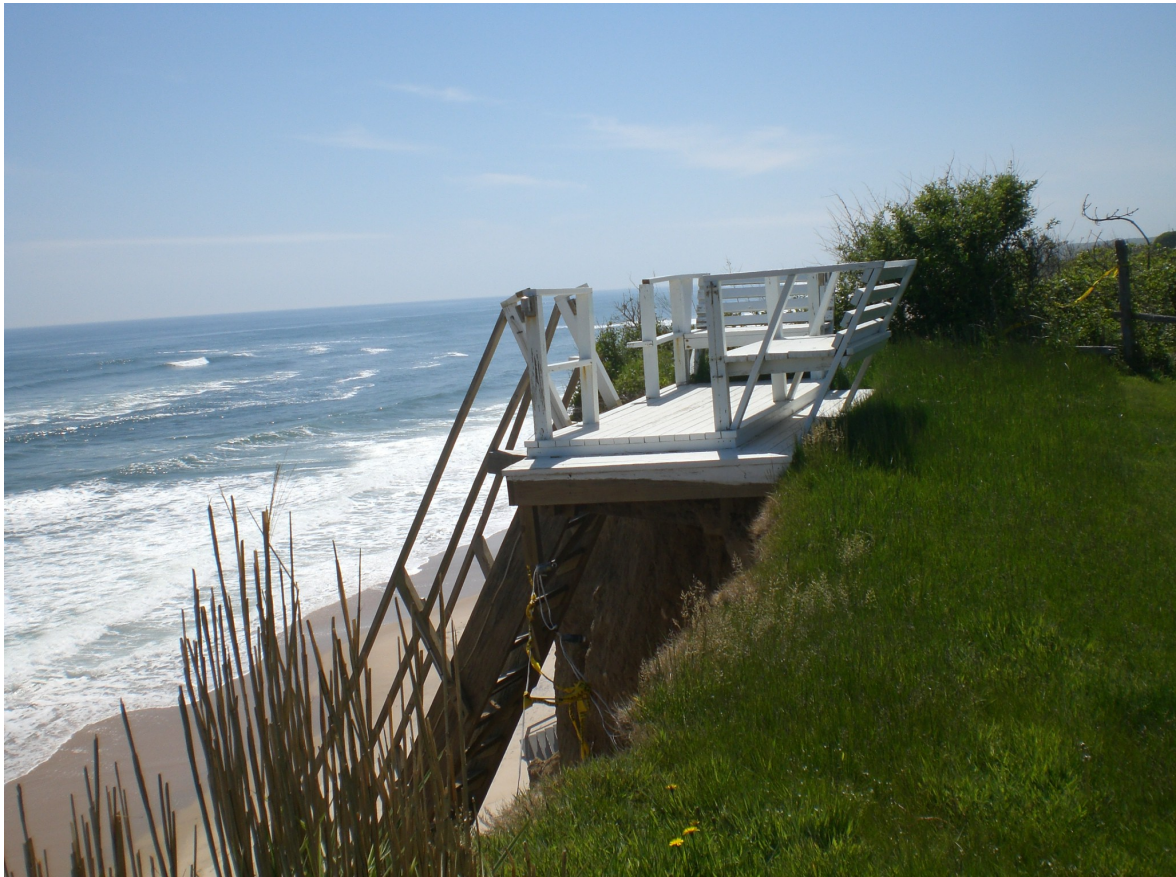
The upper platform was severely cantilevered but the grade-beam on posts design kept it in place.

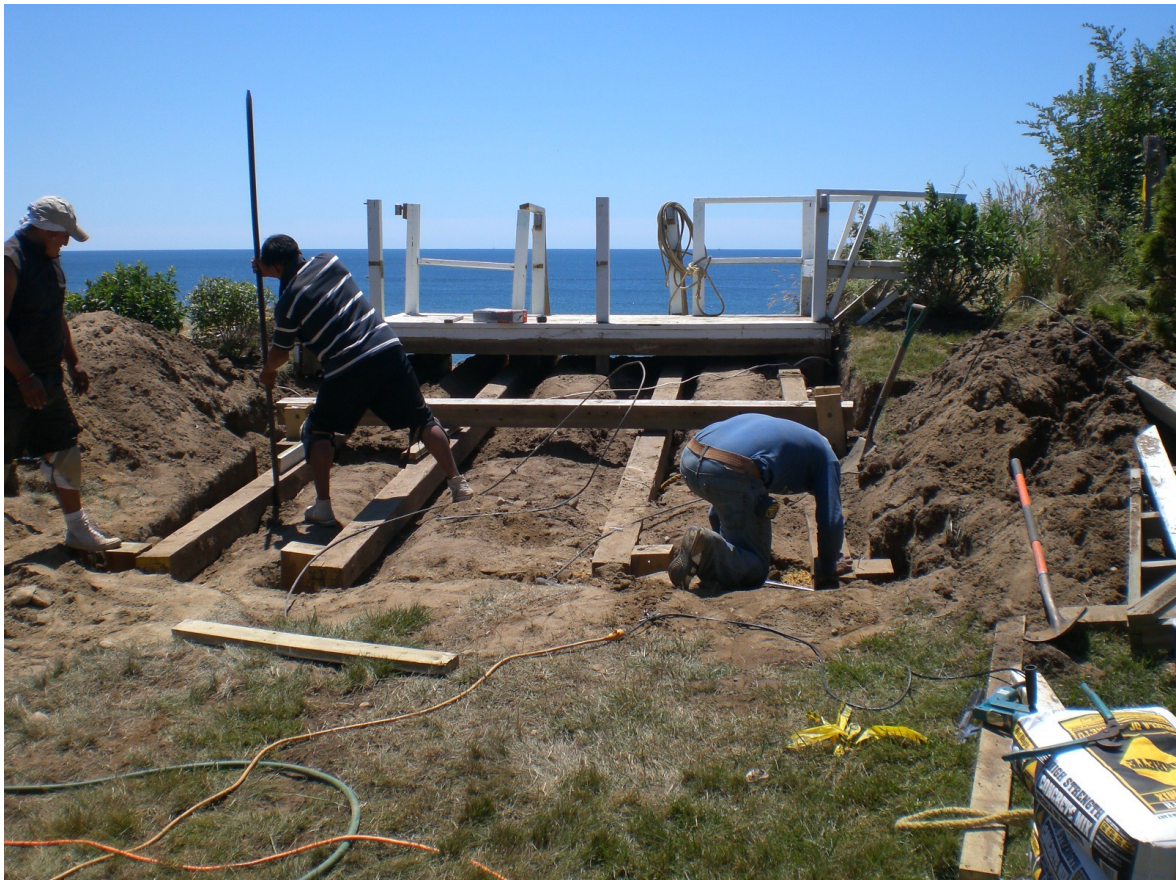
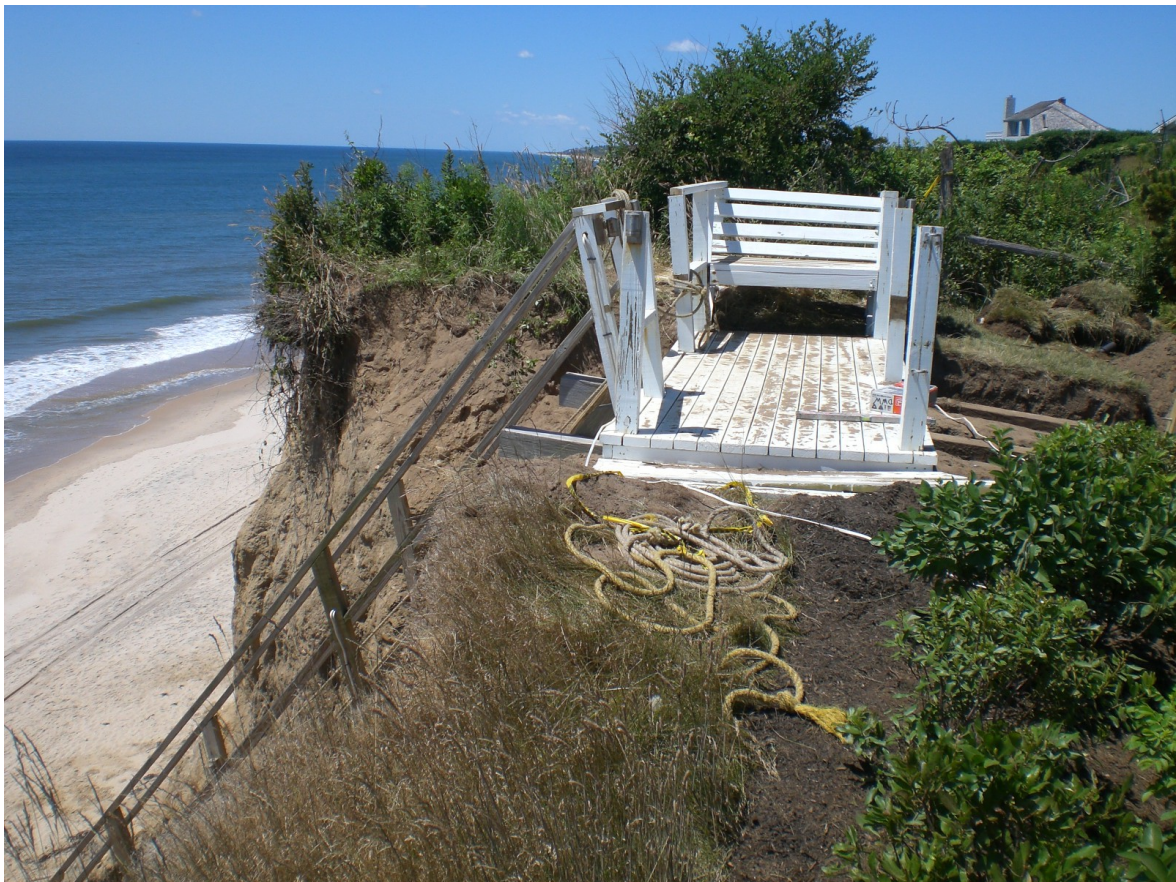
July 2010 – The grade-beams were exposed, and disconnected from their posts, allowing the crew to winch the entire structure 8' to the north. Note the tie-back cables extending from the dirt.

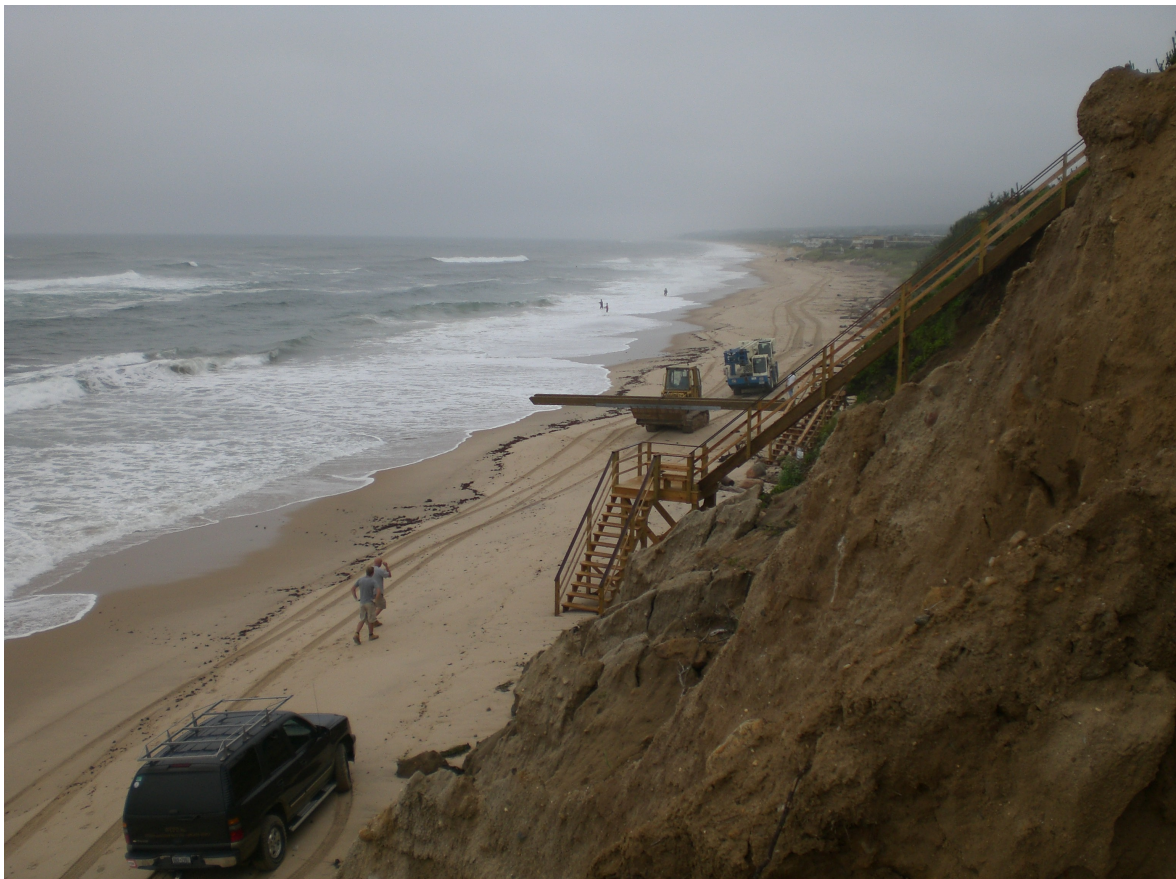
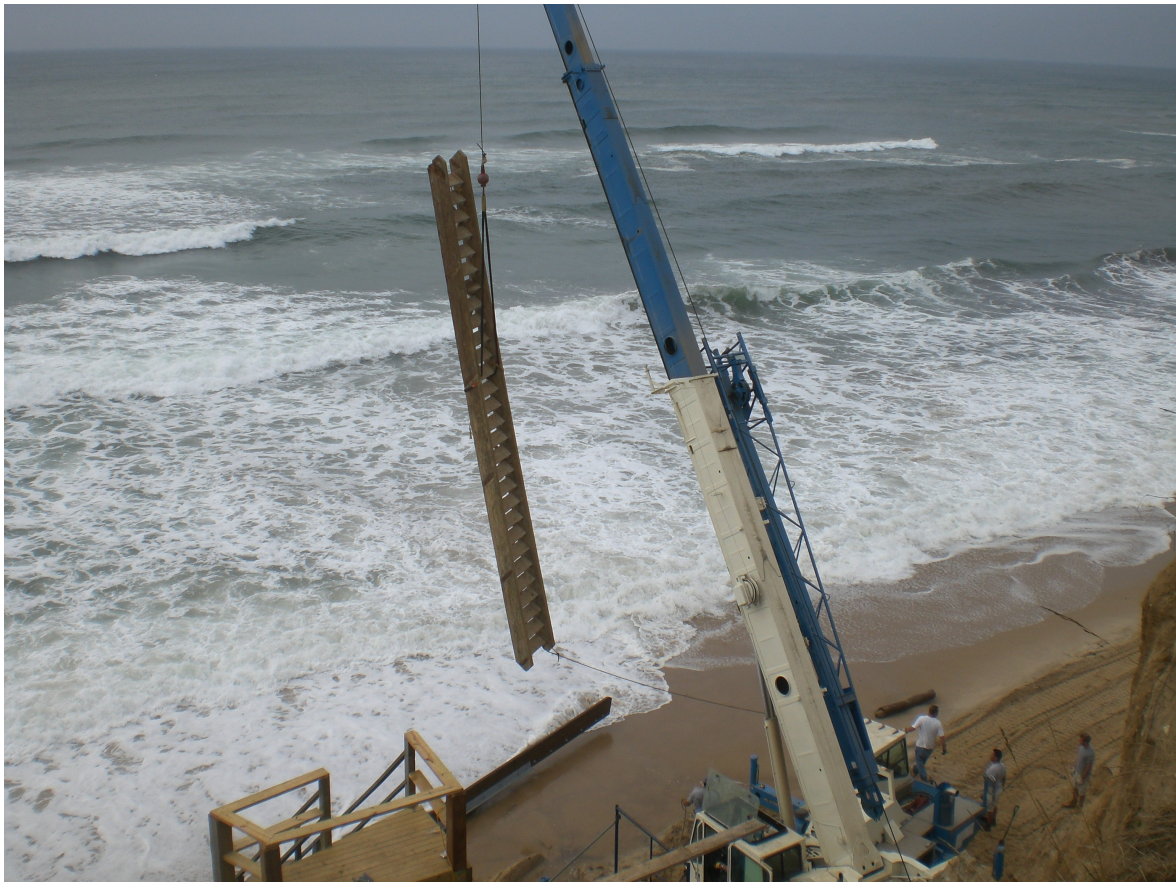
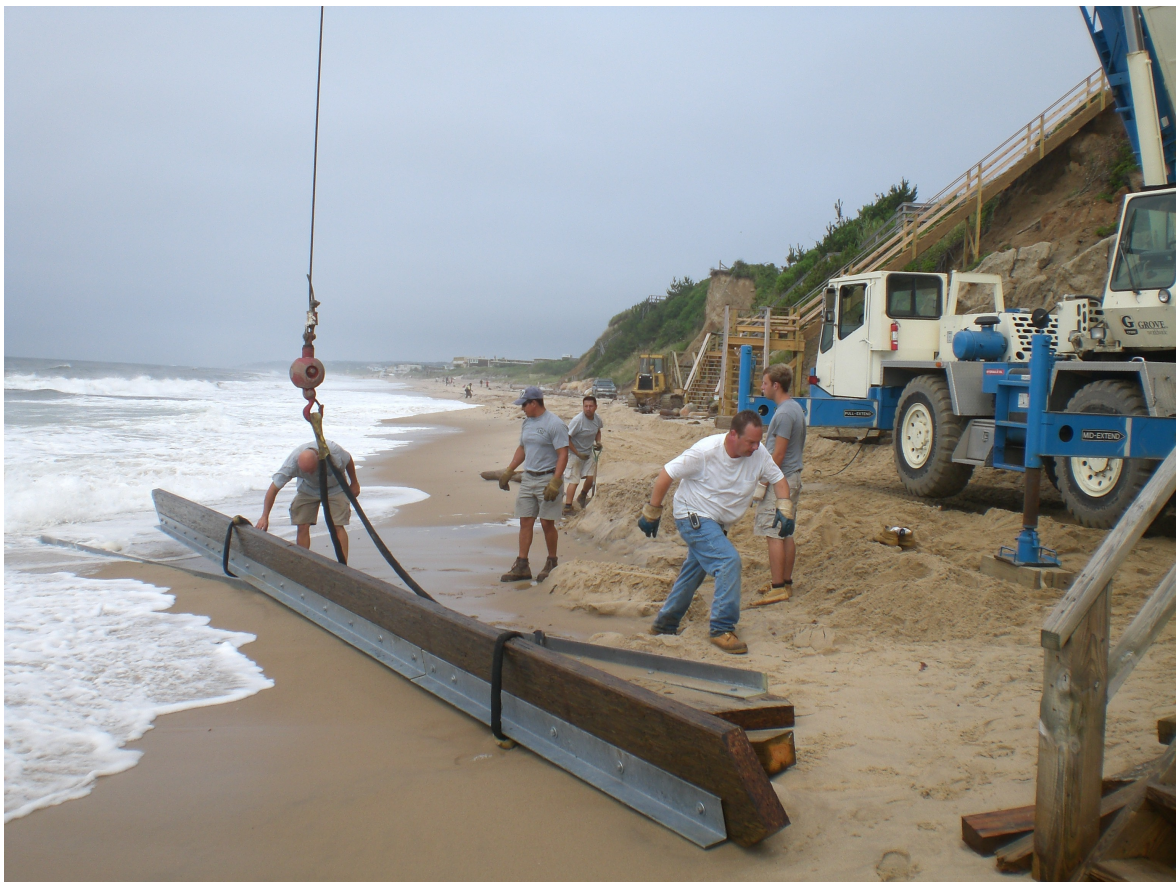
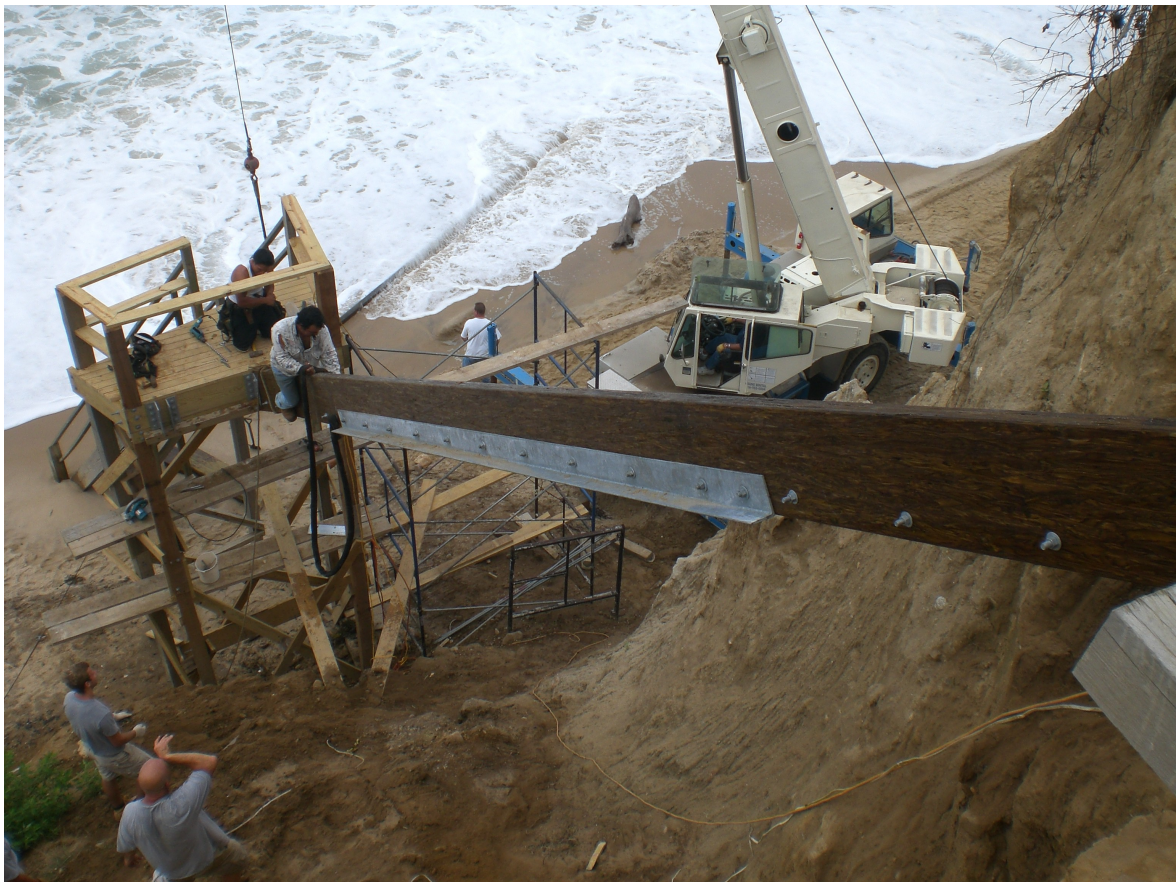
Following relocation of the upper platform, the mid-landing had to be rebuilt and a new, longer (40'), steel reinforced stair set needed to be hoisted into place once the old stair set was removed.
