Gershman Beach Stair History – Design and construction by Webb Builders, Inc.

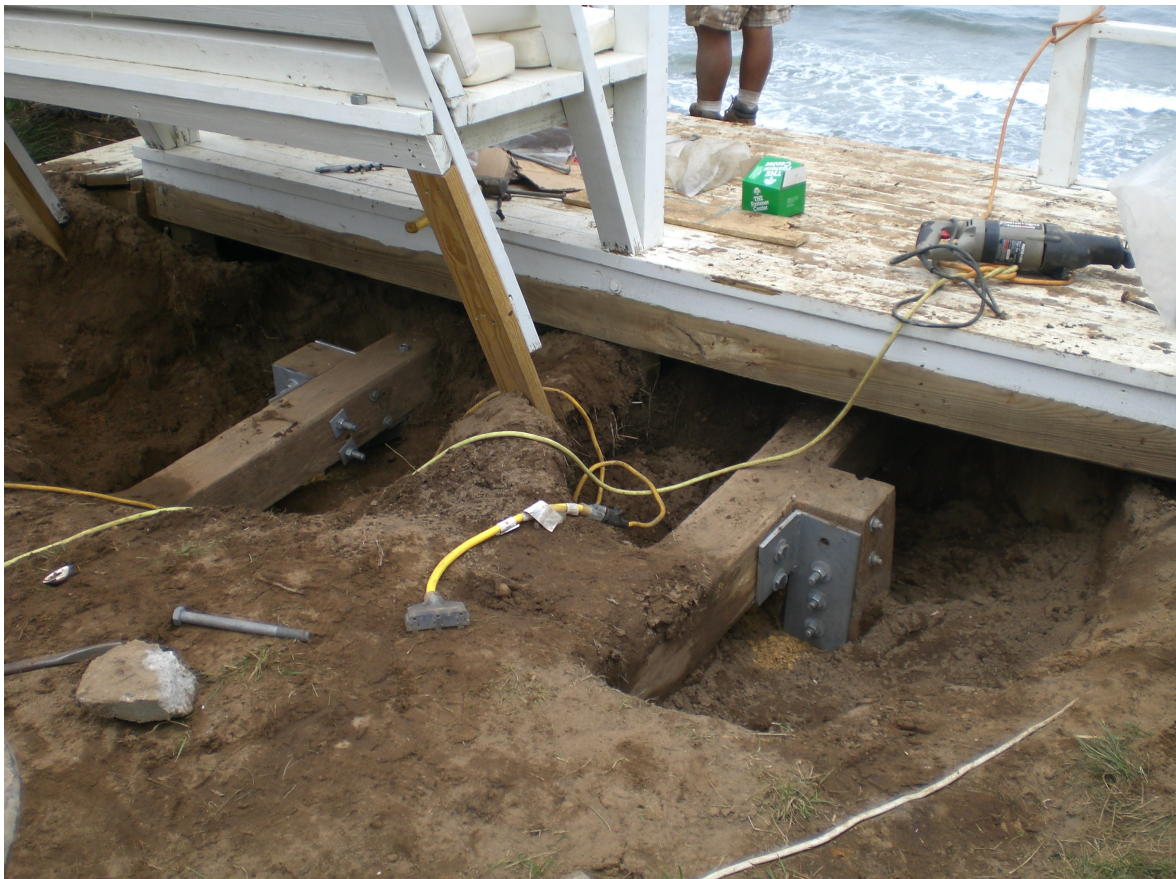
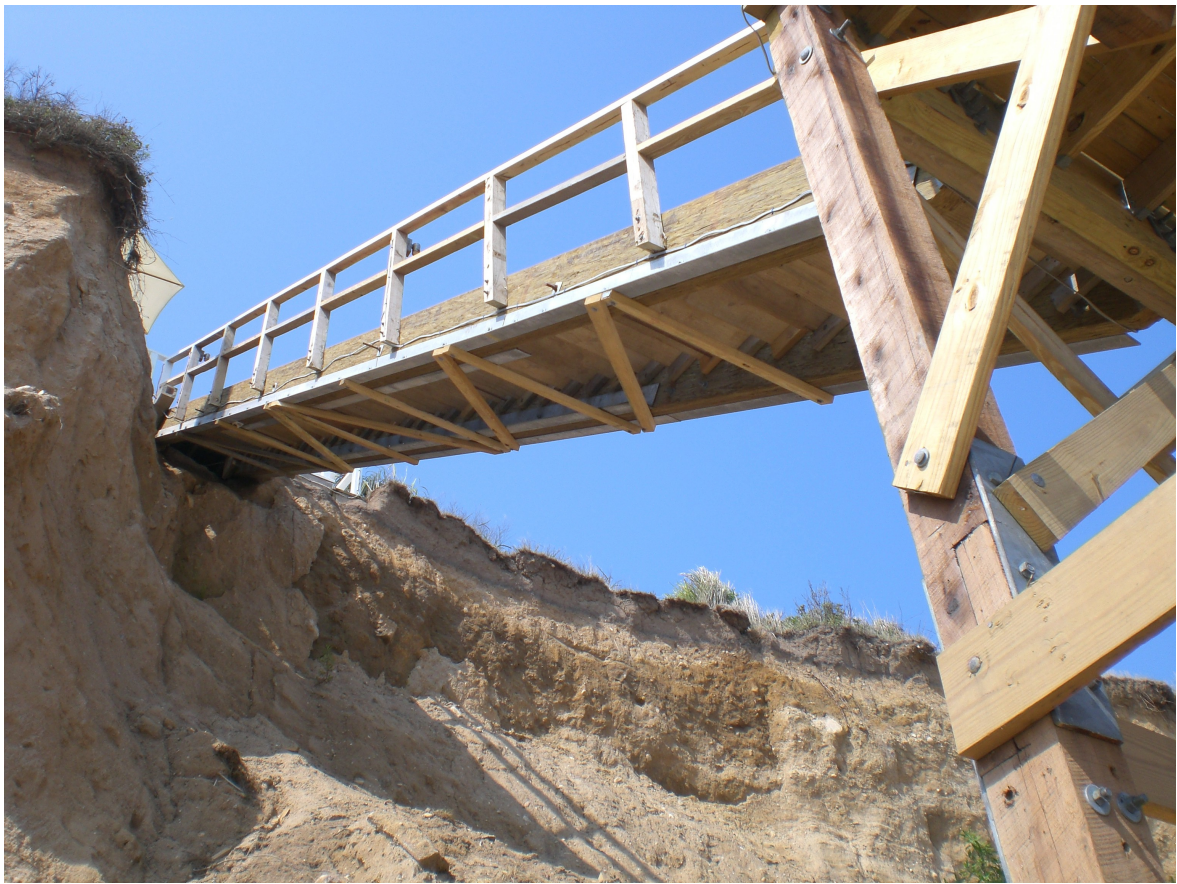
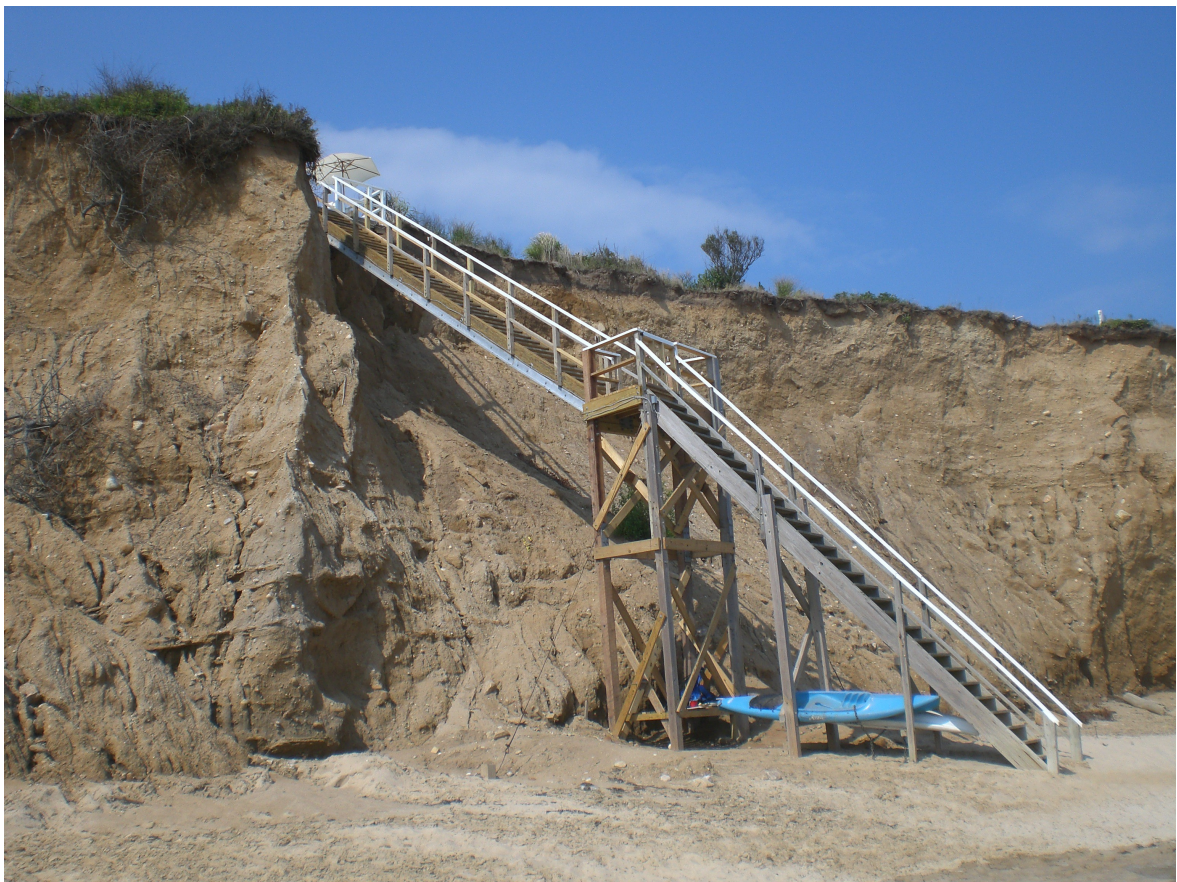
Much of the newly rebuilt and relocated structure was reinforced with steel, including the upper platform grade-beam to post connections.

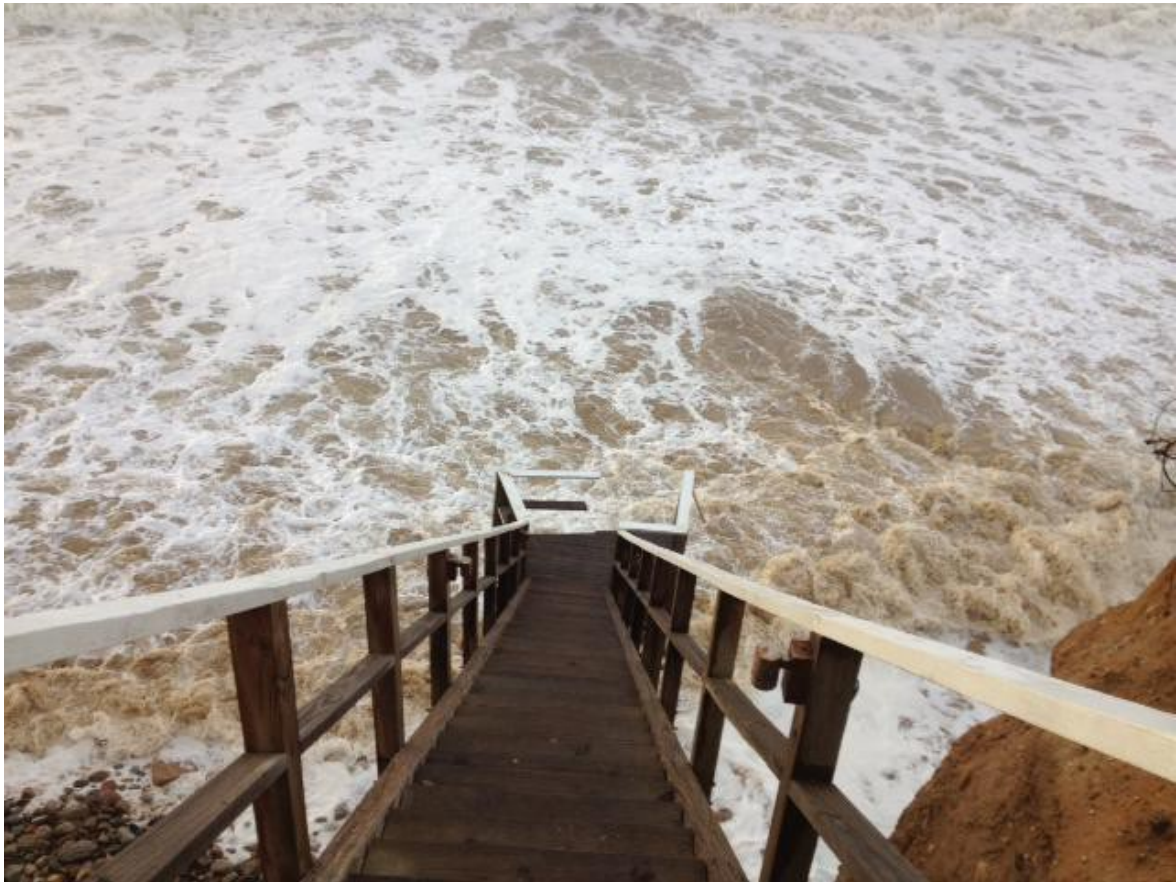
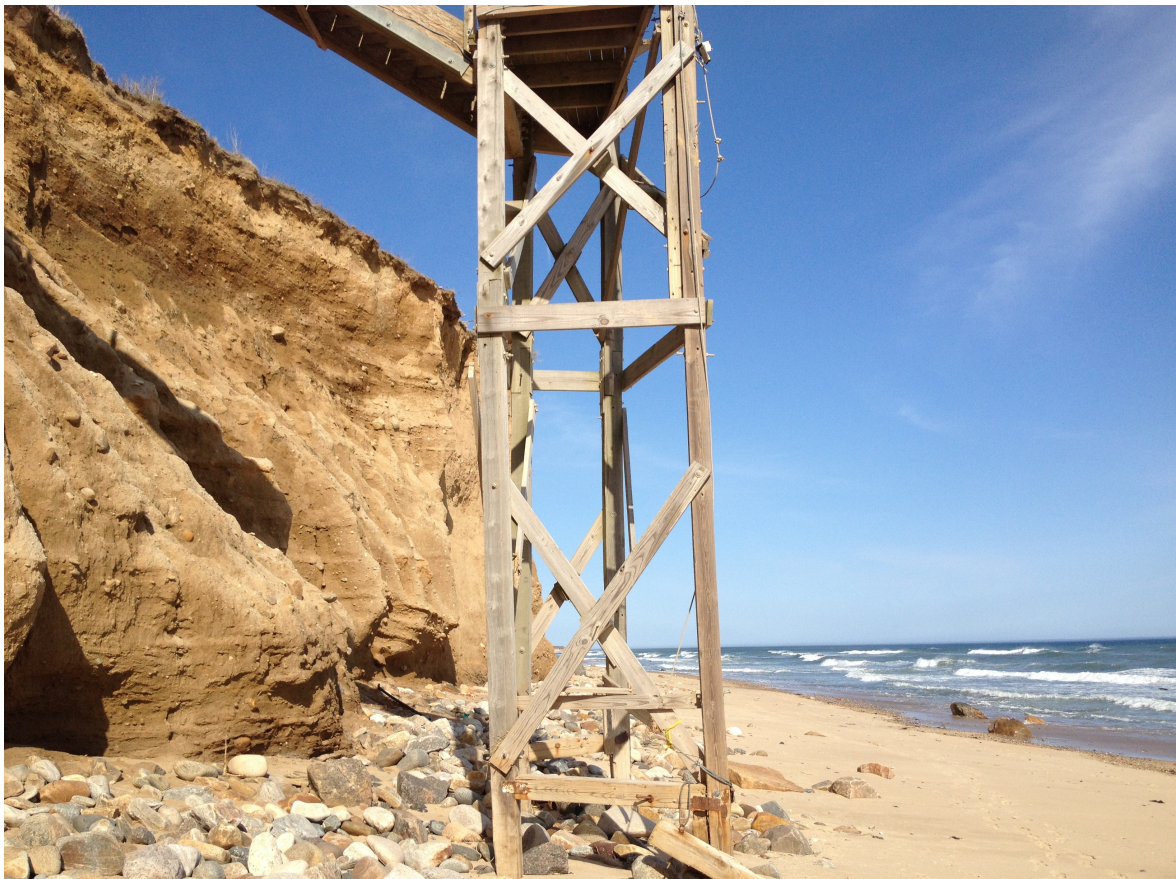
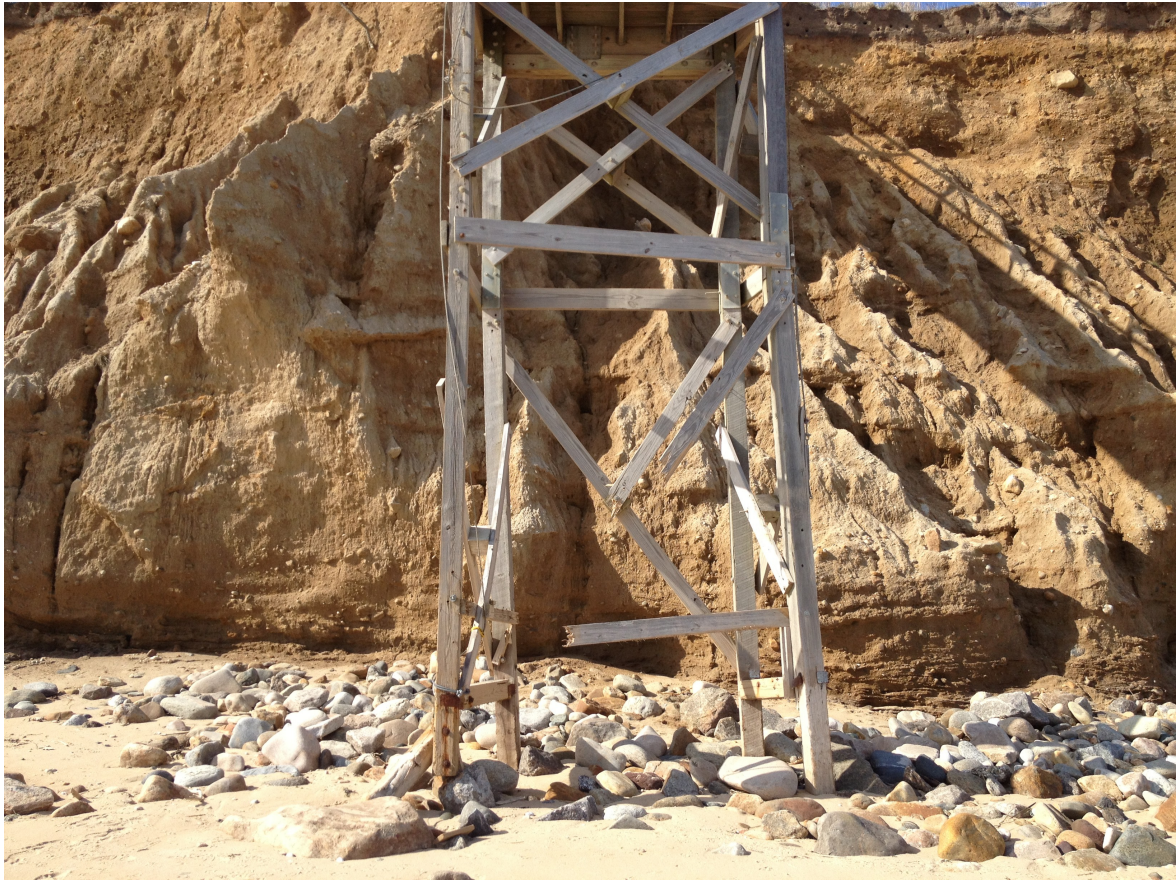
October 2012 – Hurricane Sandy took the original (2001) lower stair-set out to sea and left the mid level landing precariously standing.

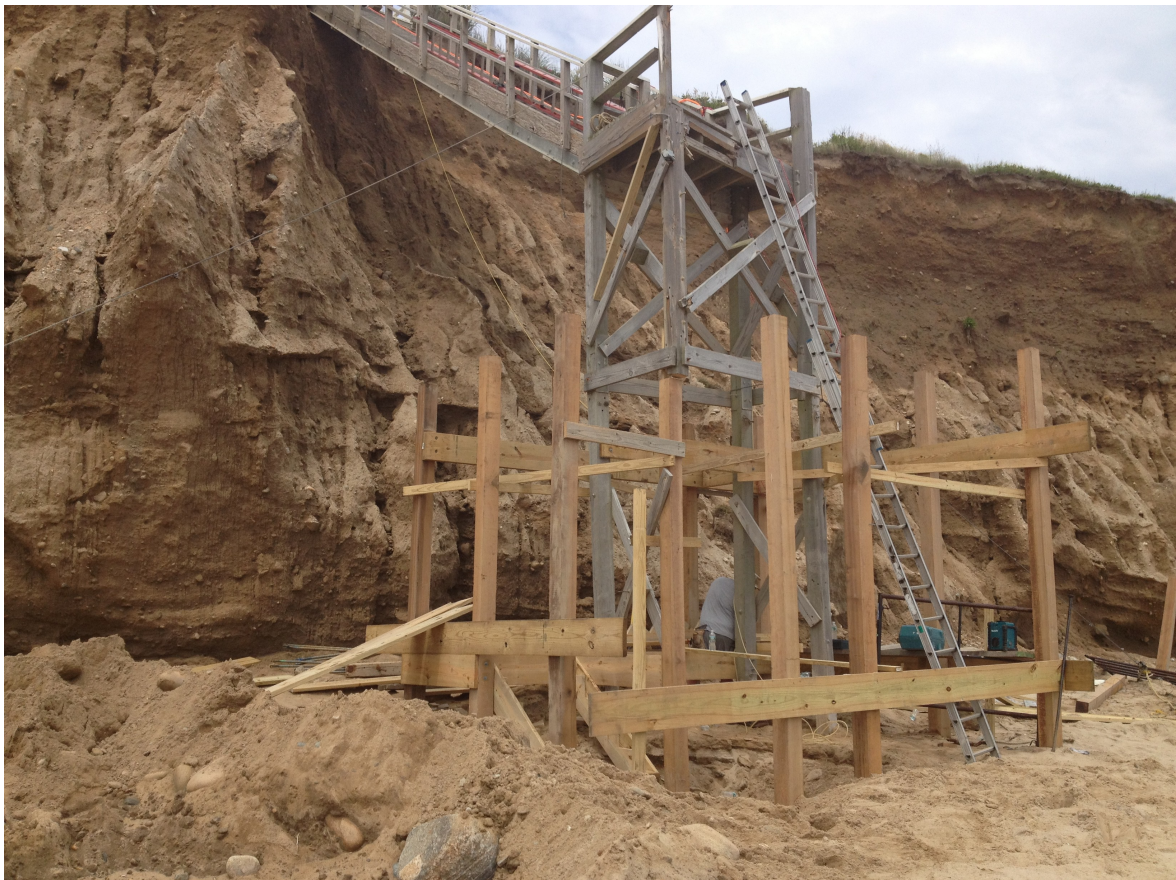
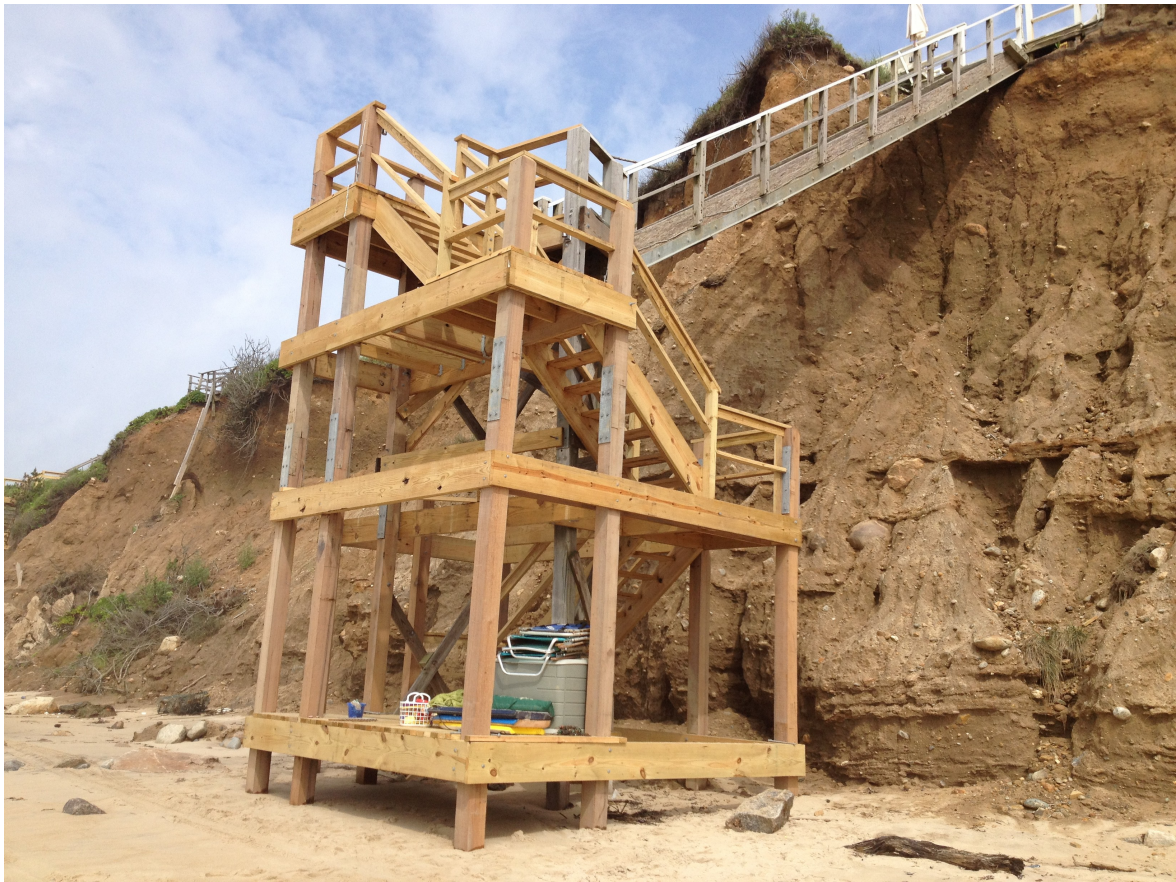
June 2013 – The solution was to build a wrap-around stair from the mid-landing to the beach. This design created an extremely solid platform with a stair which no longer impeded high-tide beach travel by extending southerly.

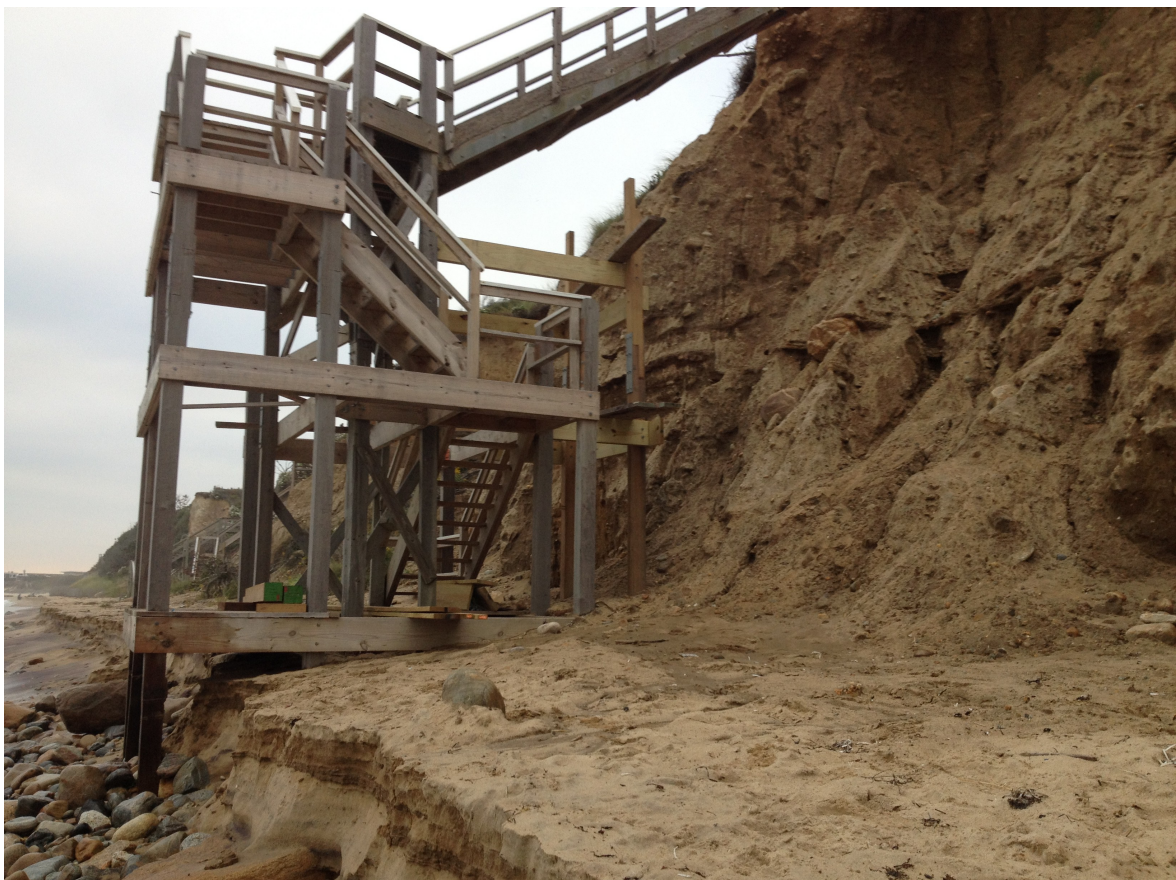
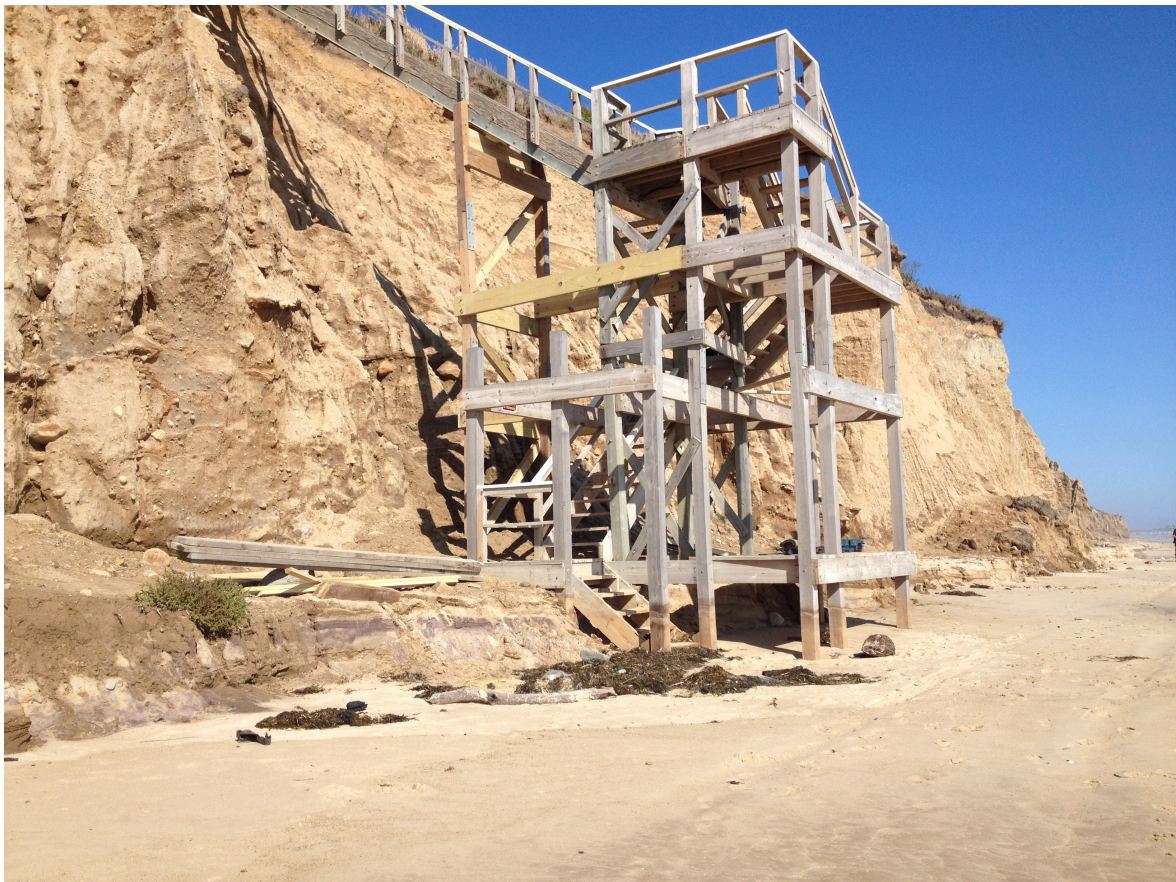
October 2014 – The 5' deep base posts weren't in danger of beach erosion but the users of the beach stairs wished to eliminate the bounciness of the 40' stair set, so an additional support was extended up from the toe of the cliff.

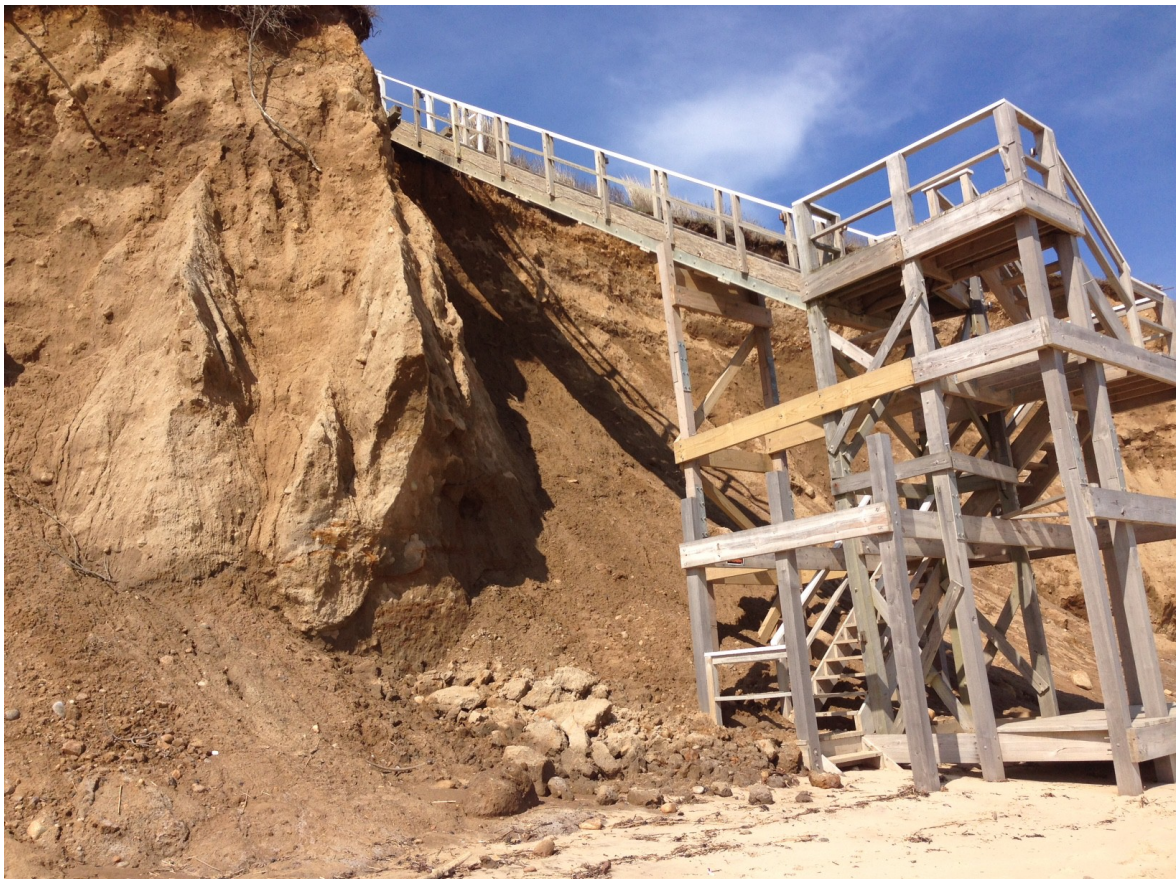
April 2015 – Mud slide from the cliff does not affect the base structure, however it does mean that the upper platform is beginning to cantilever from the cliff edge.

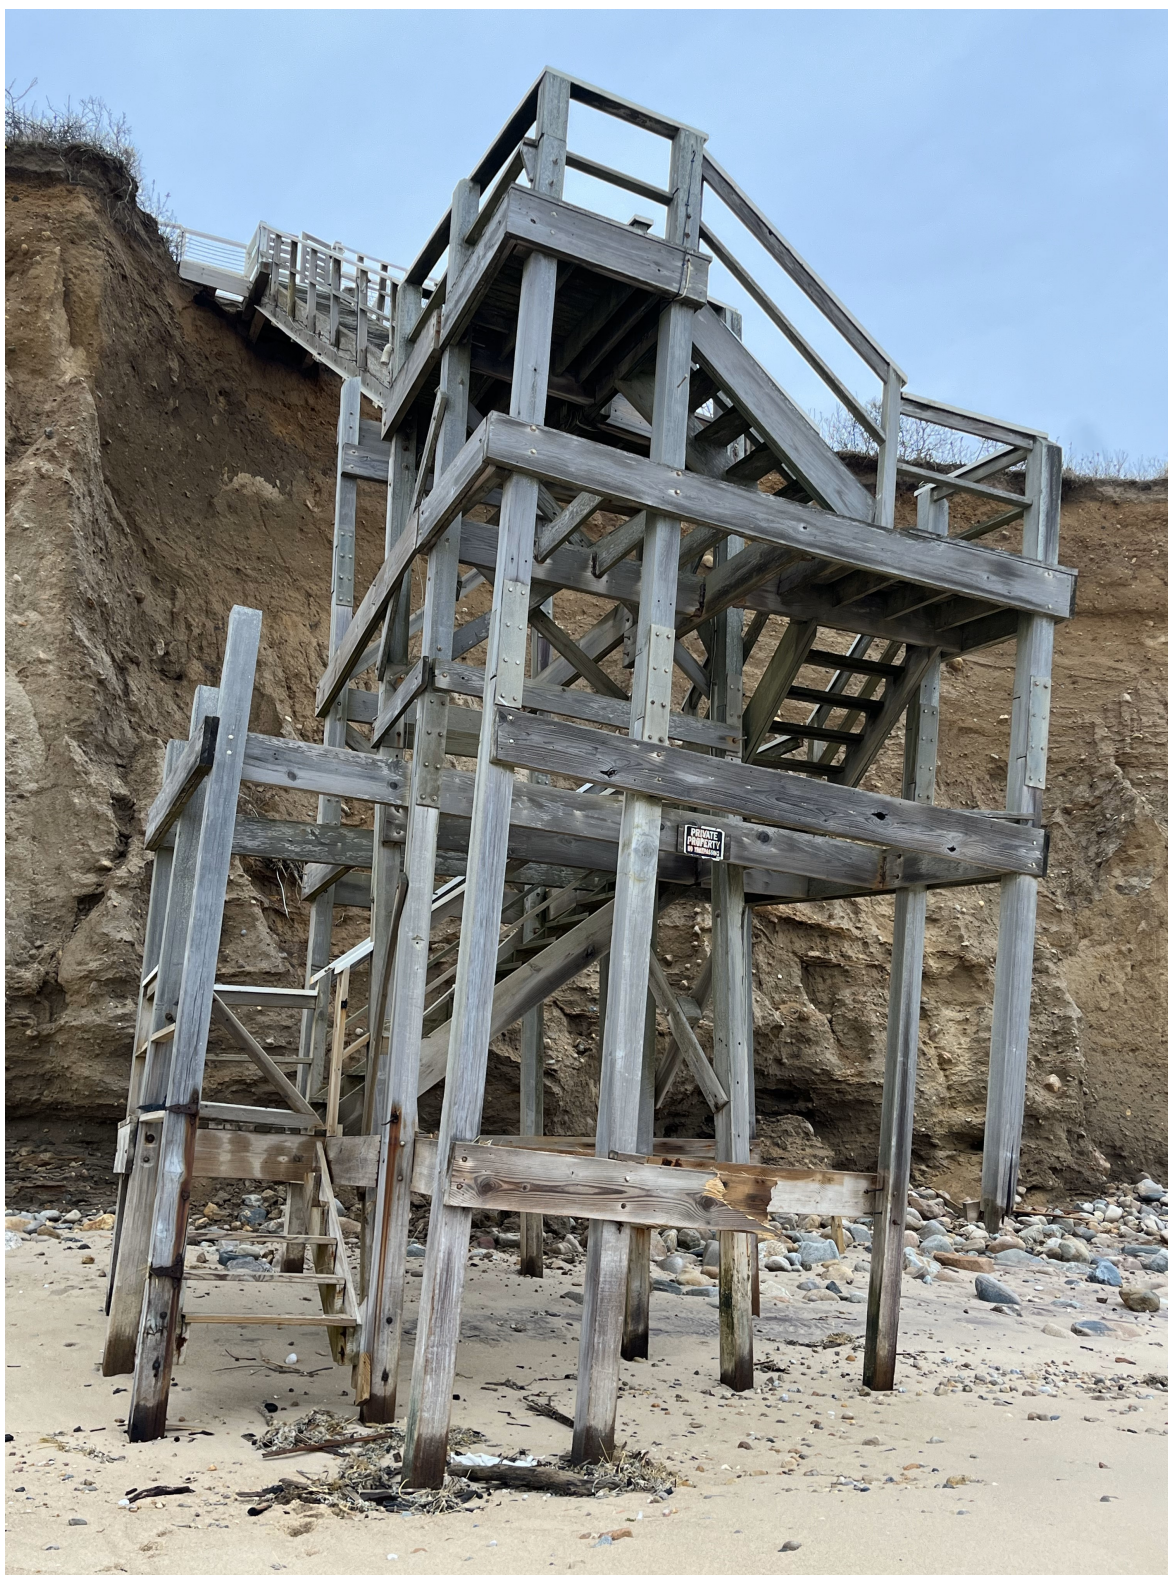
January 2024 – A winter storm caused the SE post to break off (probably because a large floating tree got caught in there) and then undermine enough of the other posts to tip the structure to the east.

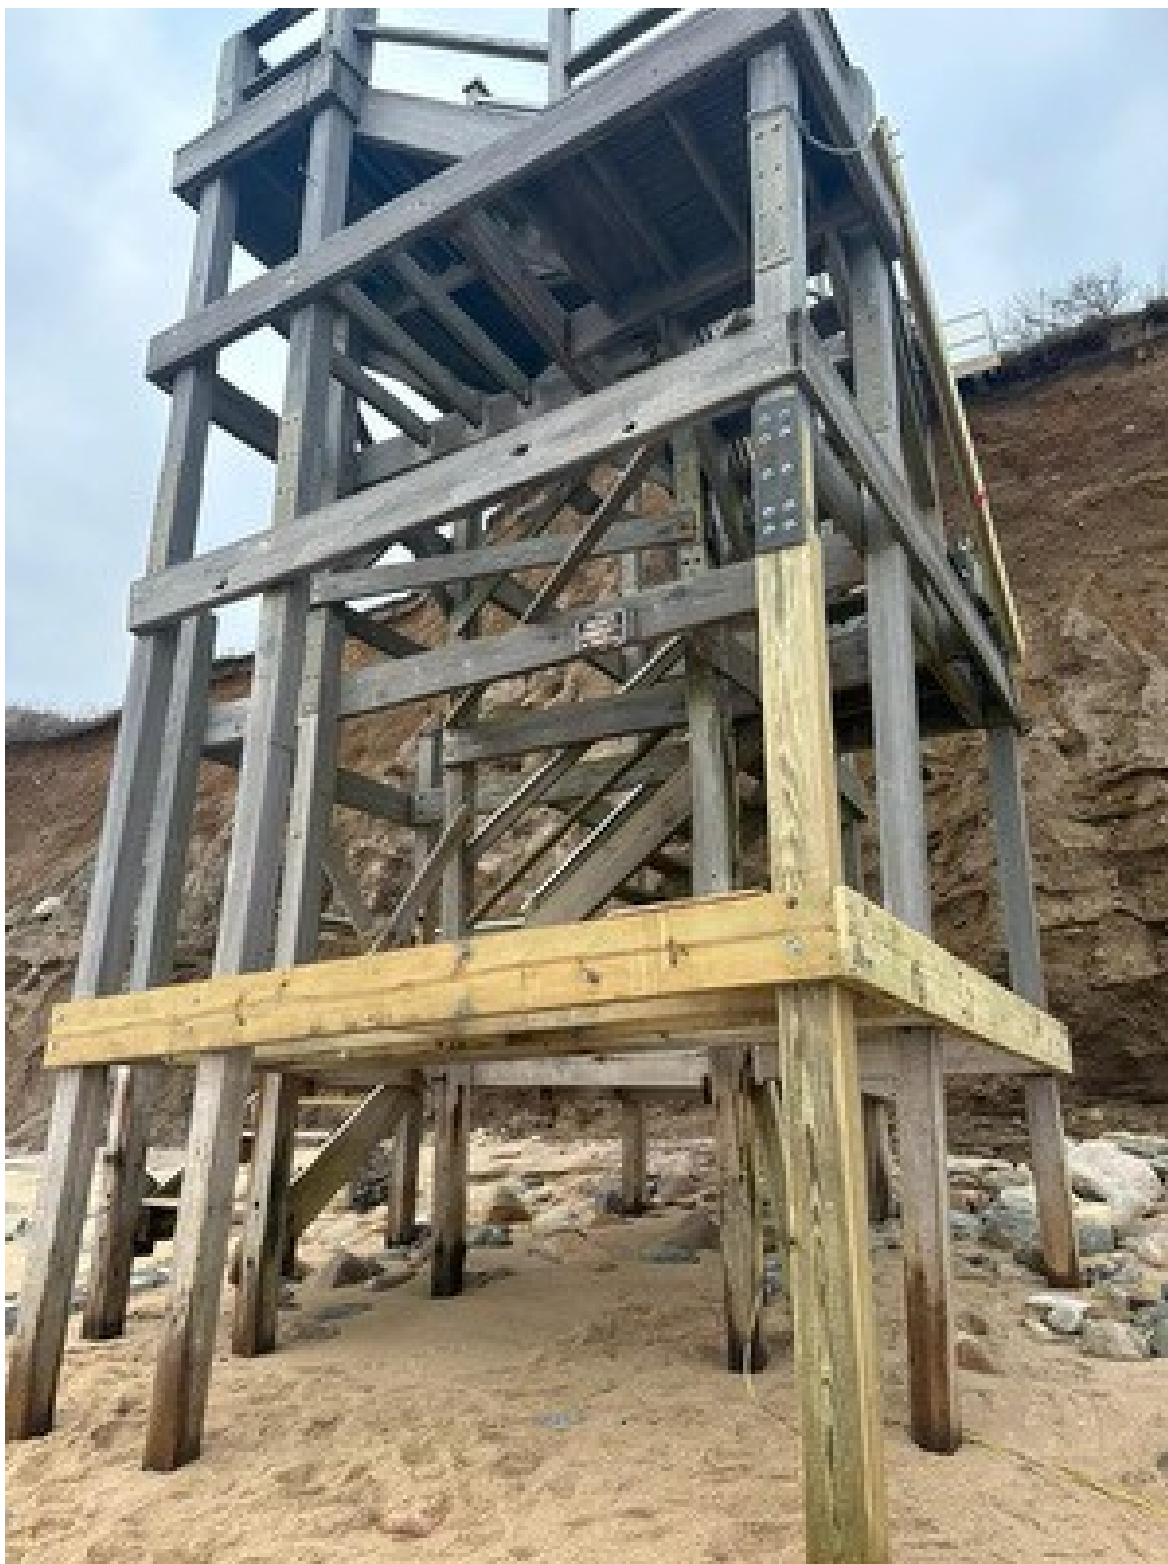
February 2024 – The structure was jacked up and the corner post was repaired.

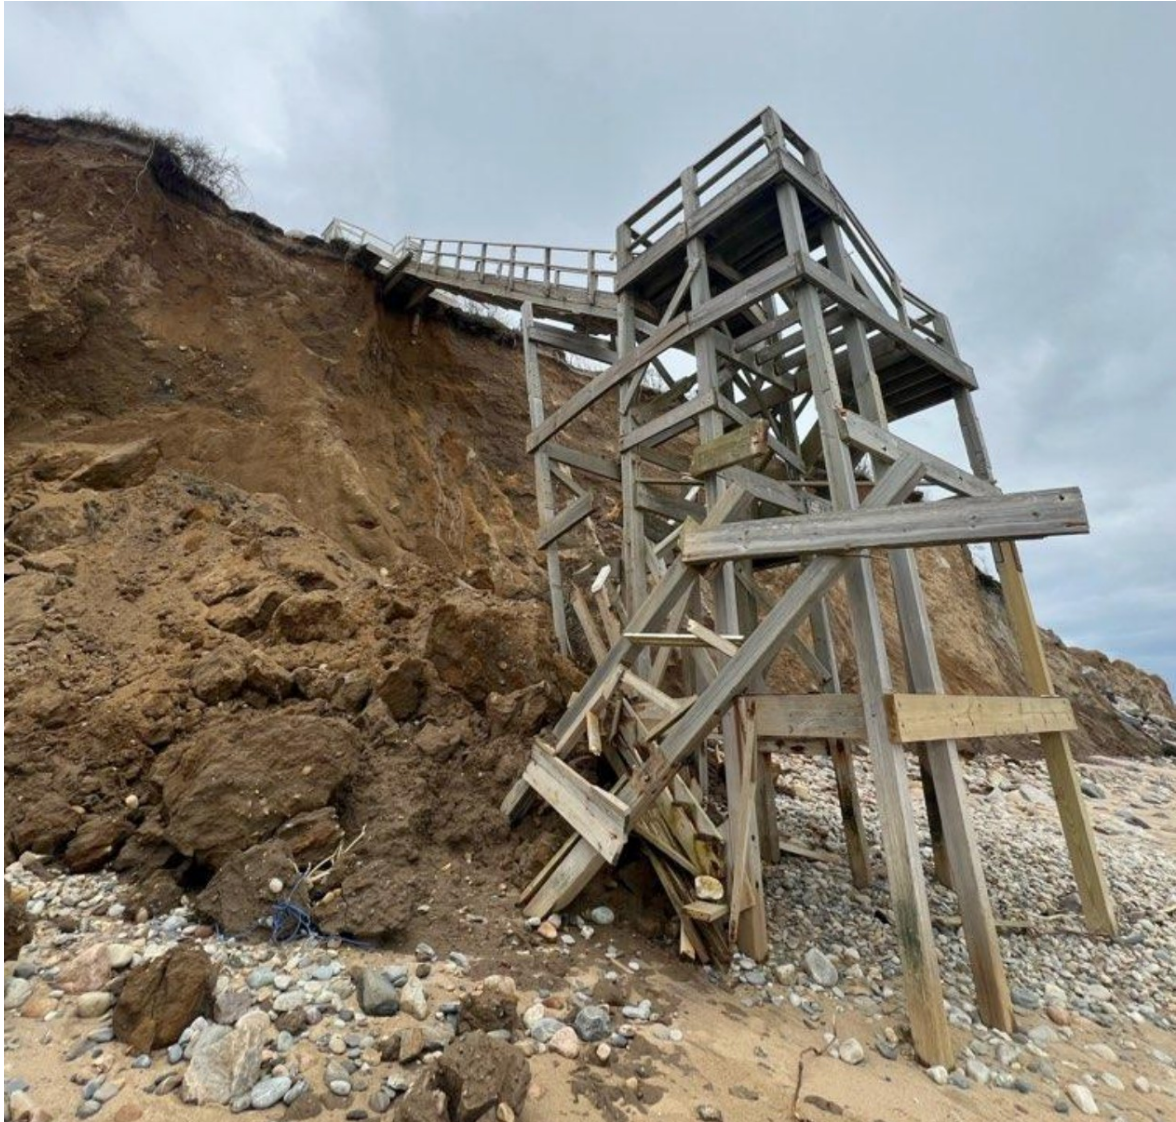
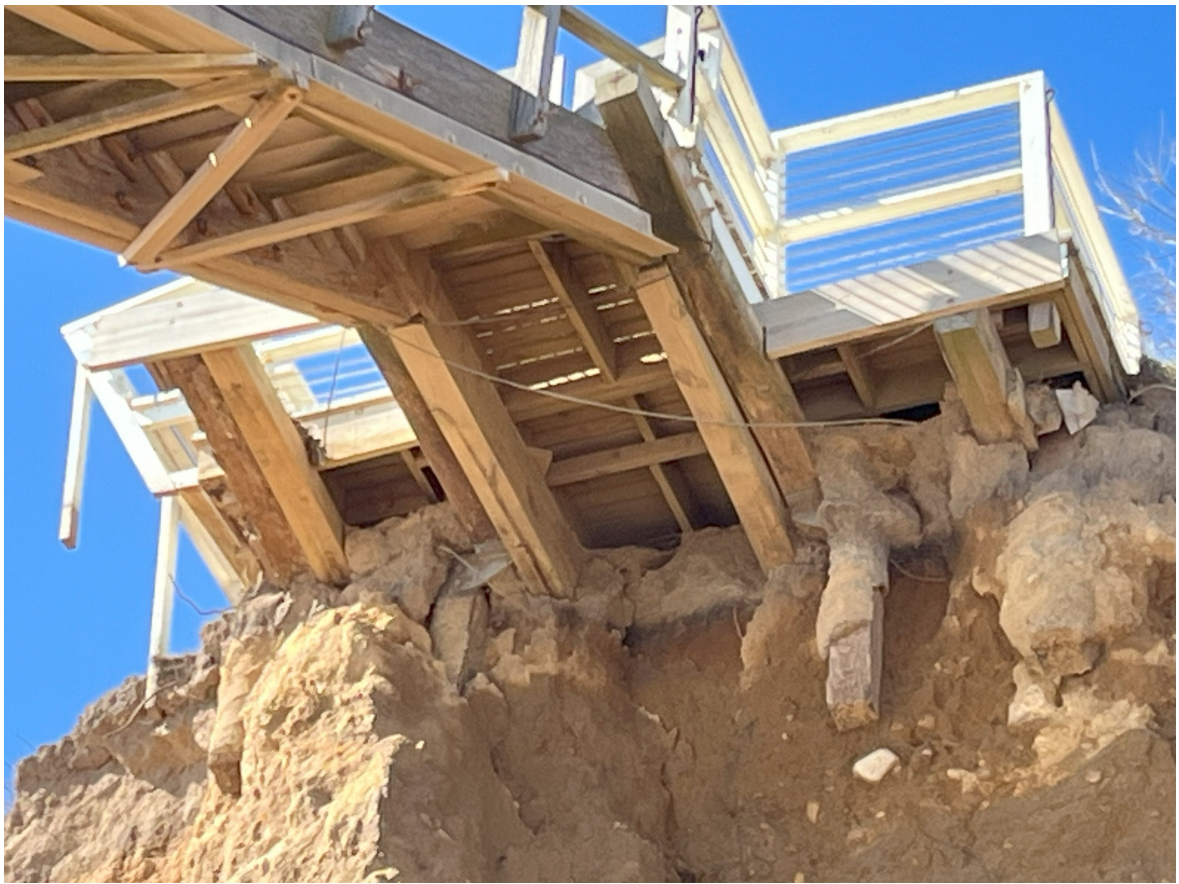
April 2024 – Major mud slide, taking 4' off the property above, came down and significantly damaged the platform and stair structure. As a result, the upper platform was left hanging off the edge of the cliff to the point where the whole structure is unsafe.
